12. COUNCIL REPORTS FOR DECISION**12.1. PORT LINCOLN TOWN JETTY SWIMMING ENCLOSURE**

REPORT INFORMATION	
Report Title	Port Lincoln Town Jetty Swimming Enclosure
Records Reference	9.24.1.2 REP23117
Organisational Unit	Environment & Infrastructure
Responsible Officer	Project Manager - Master Plan Projects - Kathleen Brannigan
Report Attachment/s	Yes Attachment 8 I223976 Assessment Report on Town Jetty Swimming Enclosure (June 2022) I231611 Peer Review of Assessment Report on Town Jetty Swimming Enclosure (July 2023)
REPORT PURPOSE	
The purpose of this report is to provide Council with a report about the current swimming enclosure pontoon structure at the Port Lincoln Town Jetty and recommend next steps.	
REPORT DECISION MAKING CONSIDERATIONS	
Council Role	Owner / Custodian - Manage community assets including buildings, facilities, public space, reserves on behalf of current and future generations
Strategic Alignment	SDP GOAL: Goal 5: Community Assets and Placemaking SDP ACTION: Not Applicable

Project No.: 22206
June 2022

PEER REVIEW OF SWIM ENCLOSURE FAILURE REPORT

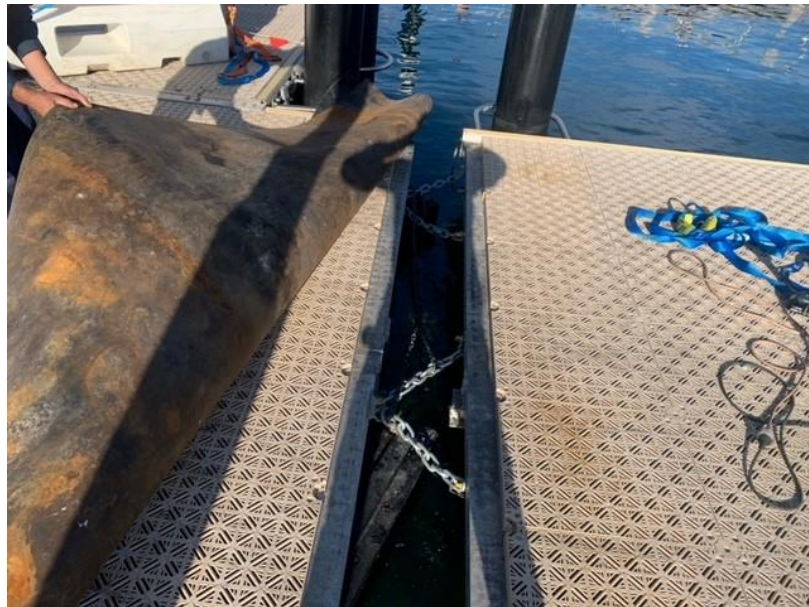
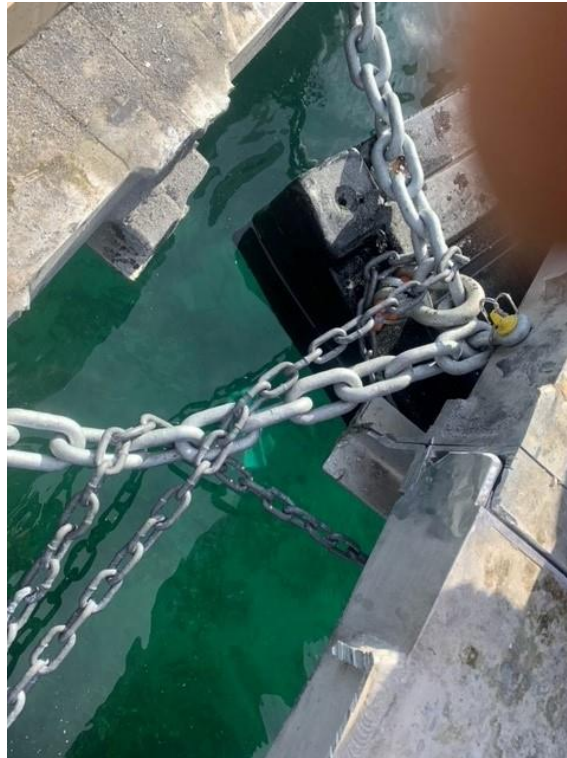
- A major break in the pontoon frames of P18 and P19, in line with the inner side of P20. The P18 and P19 frames have completely broken through the whaler members, and are no longer connected. The pontoon parts are now chained together, with barriers over to prevent people accessing the pontoons.

- Repair of pontoons P18 and P19, including:
 - Incorporation of new joints into P18 and P19 at the break line (in line with the inside face of P20). This reduces the length of the pontoons P18 and P19 from 12m to 7.5m.
 - Repair of all broken welds and replacement of all damaged aluminium sections on P18 and P19.
- Incorporation of new connections between pontoons to allow more movement and rotation between pontoons, particularly between:
 - P19 A and B (being the two new pontoons replacing P19)
 - P18 A and B (being the two new pontoons replacing P18)
 - P17
 - P16
 - P20
 - P21
 - P11
 - P9
 - P10

These new joints are recommended to be the articulating bracket type, as detailed on AC4515-16/4.

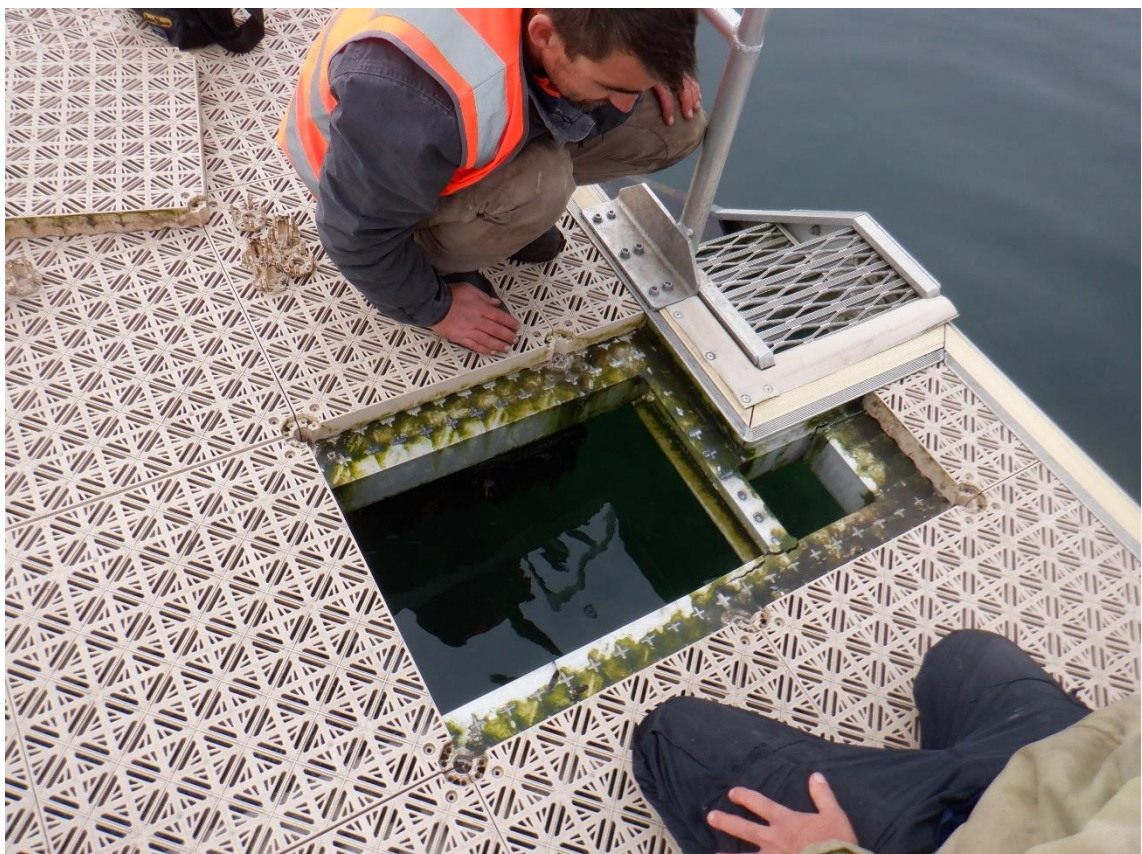
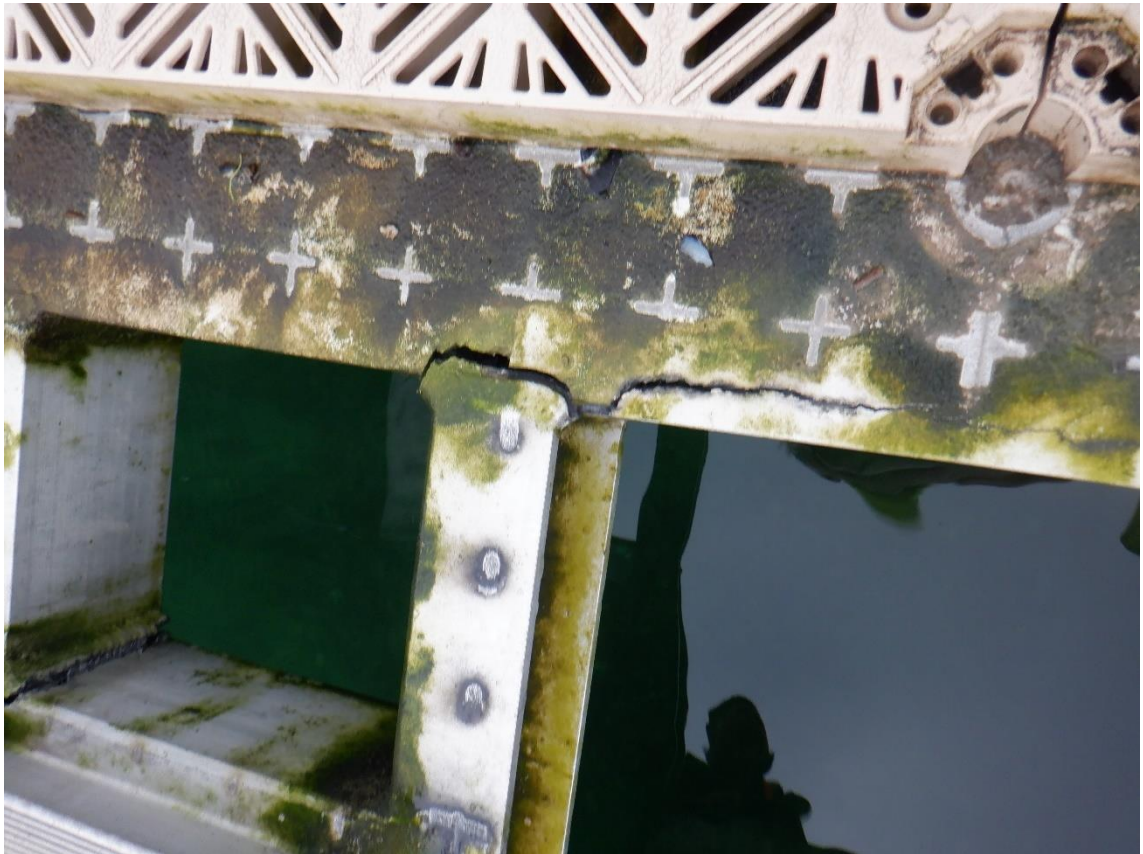
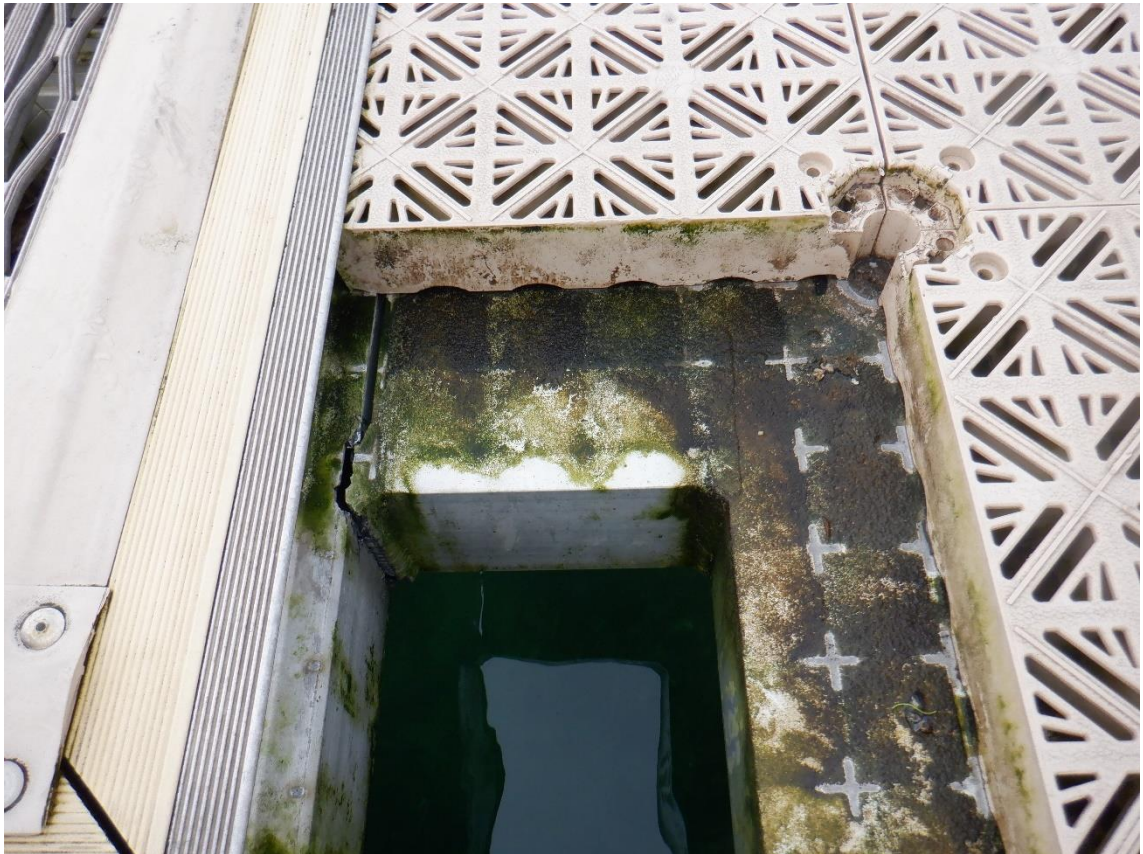
- The P13 pontoon aluminium frame at the south western corner of the steps into the water is showing severe cracking at the weld to a cross member, in two locations.

All four step pontoons show cracking of welds and/or members in the pontoon frame at one or both supporting corners of the steps.

- Testing and inspection of all welds at the top of all step platforms on pontoons P4, P8, P13 and P22. Repair of all welds as required.
- Removal of step platforms into the water on pontoons P4, P8, P13 and P22, or redesign of the supporting aluminium frame structure at each end of the steps to more fully support the steps without creating torsion into the frame. This will require a full structural review of the framing of these pontoons.

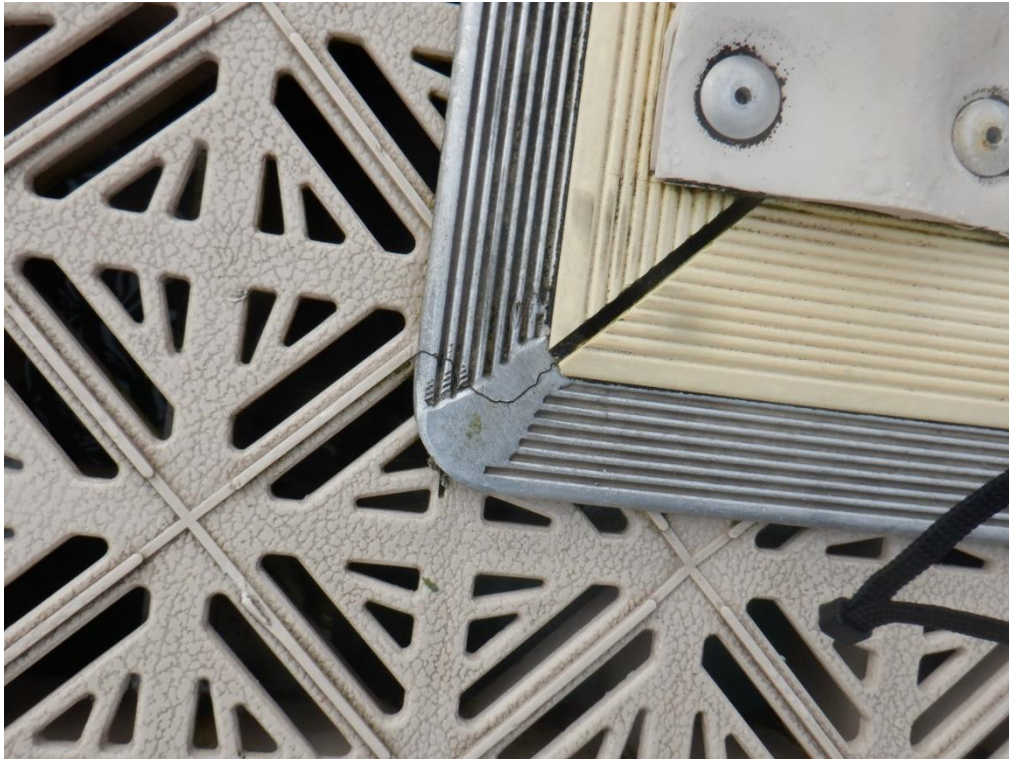
It is also showing cracking in the aluminium member at the other corner of the steps.

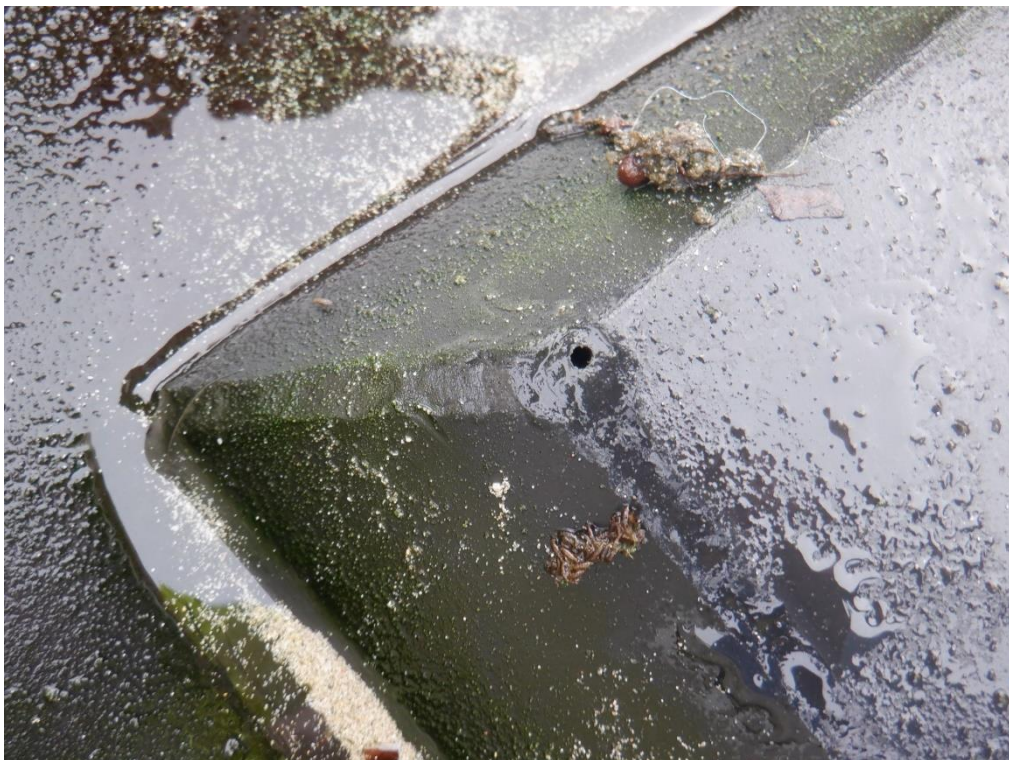
- Breather holes have been drilled into the tops of some floats.

- Water penetration into the floats, either through damage, or via the breather hole or an inspection port into the float.
- The weight of the marine growth on the pontoons and/or nets under.
- The nets being caught in debris on the seabed, preventing the pontoons from rising with the tide.

- Inspect all floats for water ingress and/or damage. Damaged floats or those with water ingress should be replaced with new. Consideration should be given to filling the floats with expanding polystyrene foam to prevent/limit water ingress in the future.

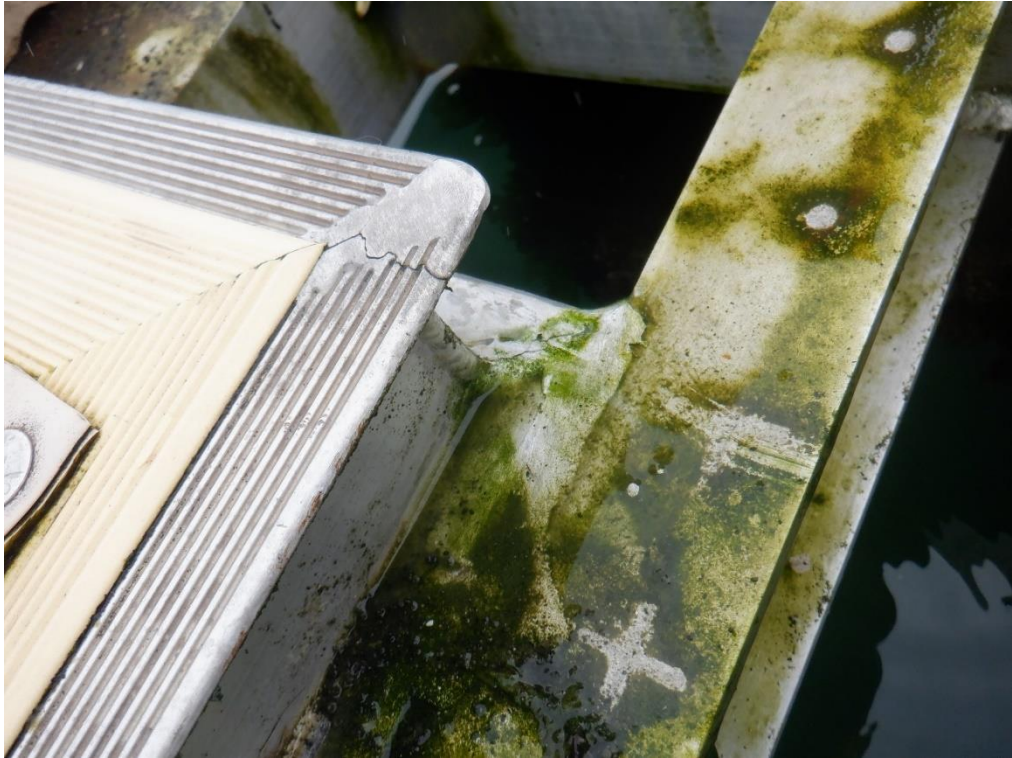
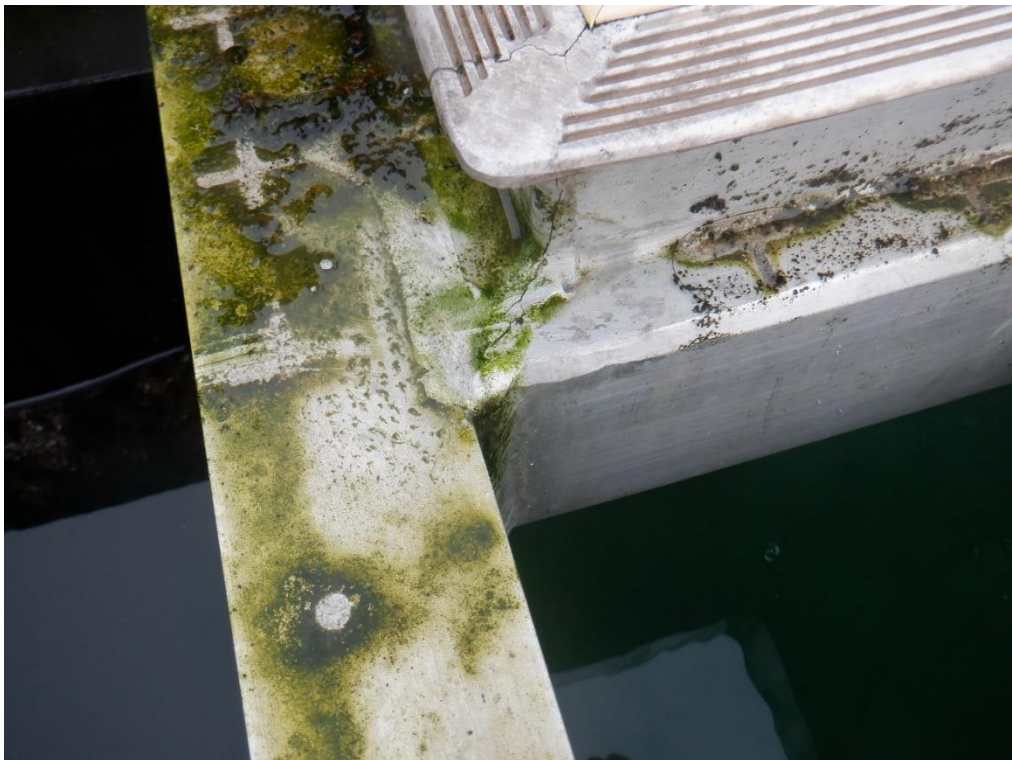
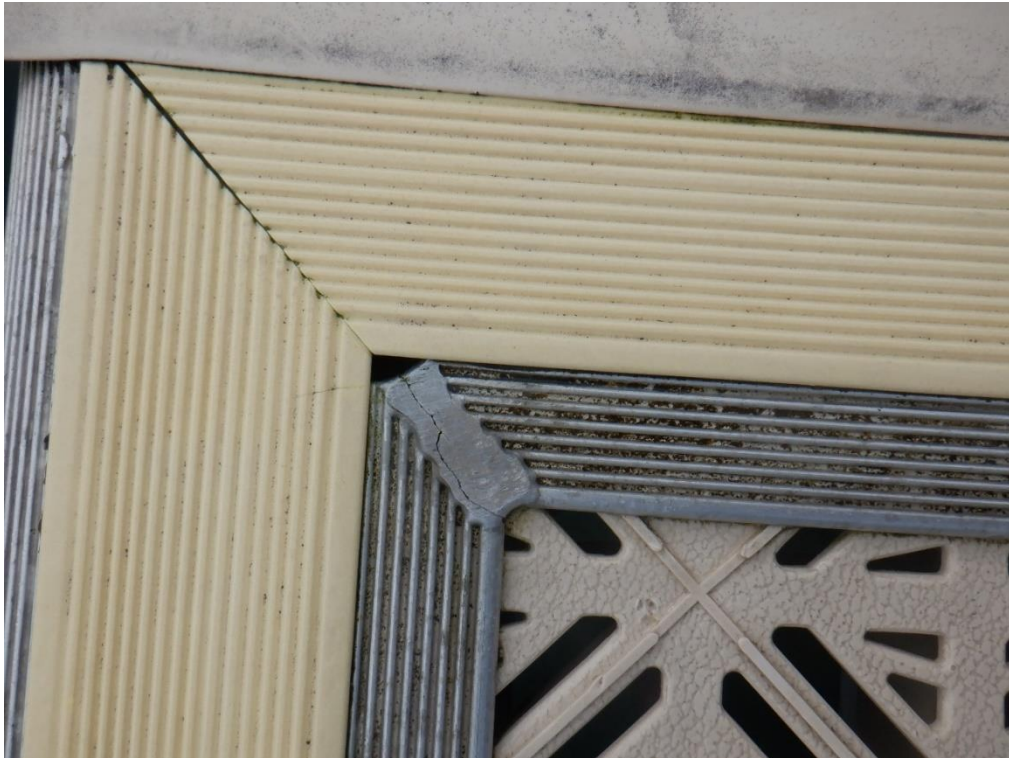
- The pontoon aluminium frame on pontoon P4 is showing cracking at both corners of the steps into the water.

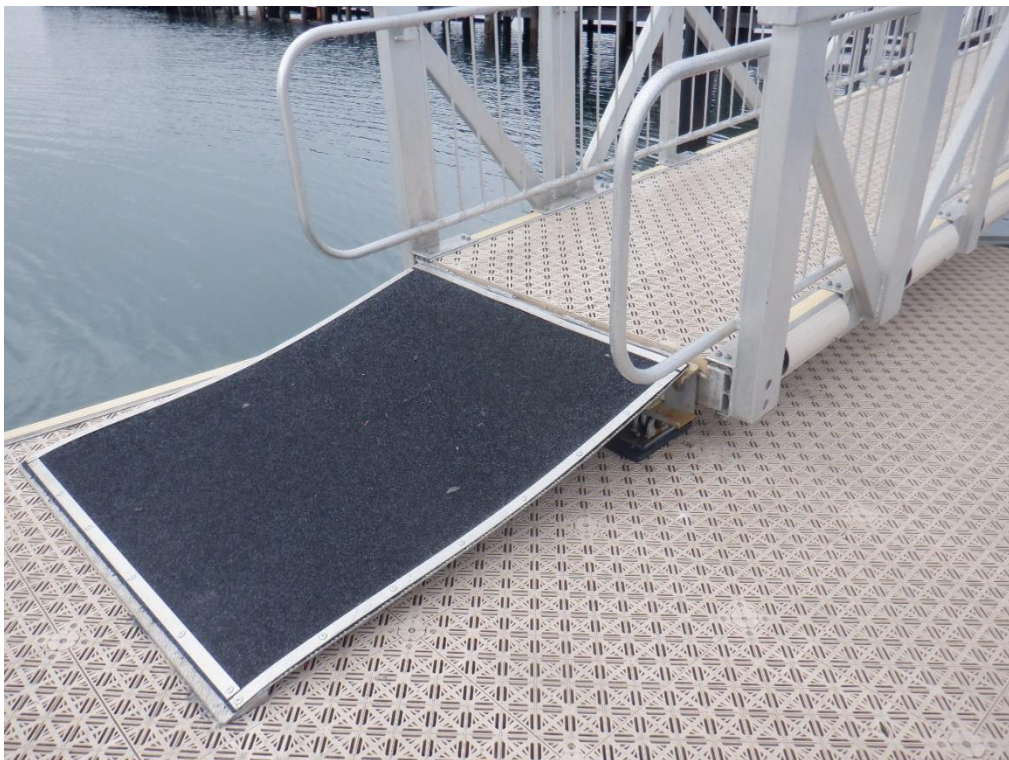
- The walkway plate from the northern gangway to the pontoons appears bent.

The only defect noted was the rotating connection plate from the bottom of the gangway onto the pontoon, which appeared to have been overloaded and bent downward in the centre.

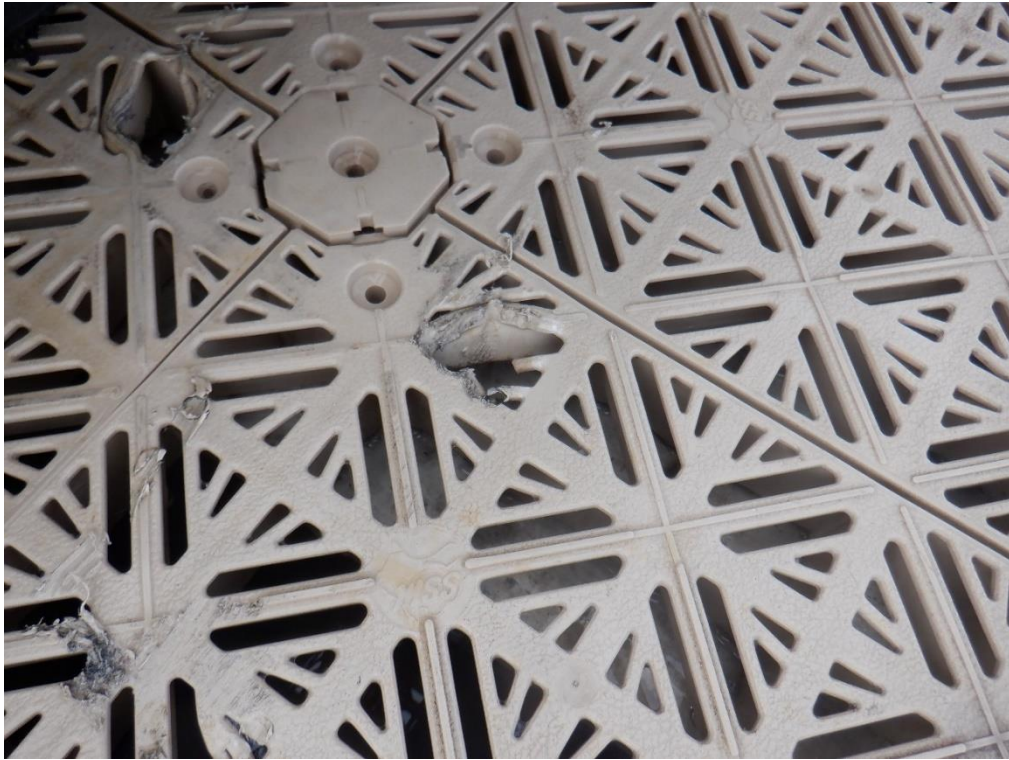
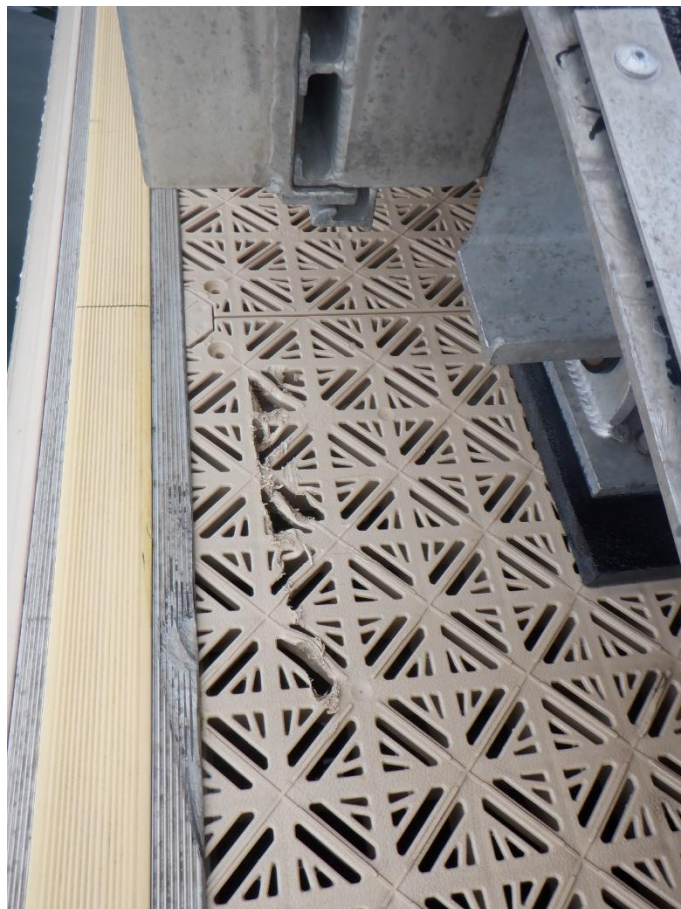
- The deck mats at the north western end of the north eastern gangway are damaged, possibly during installation of the gangway.

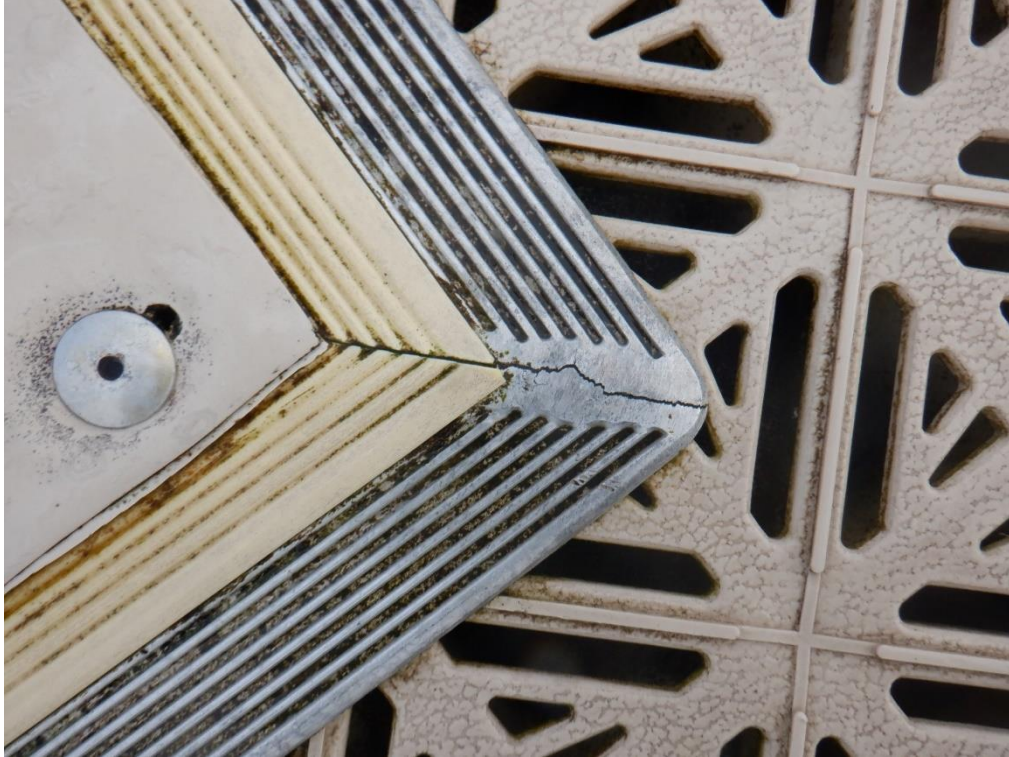
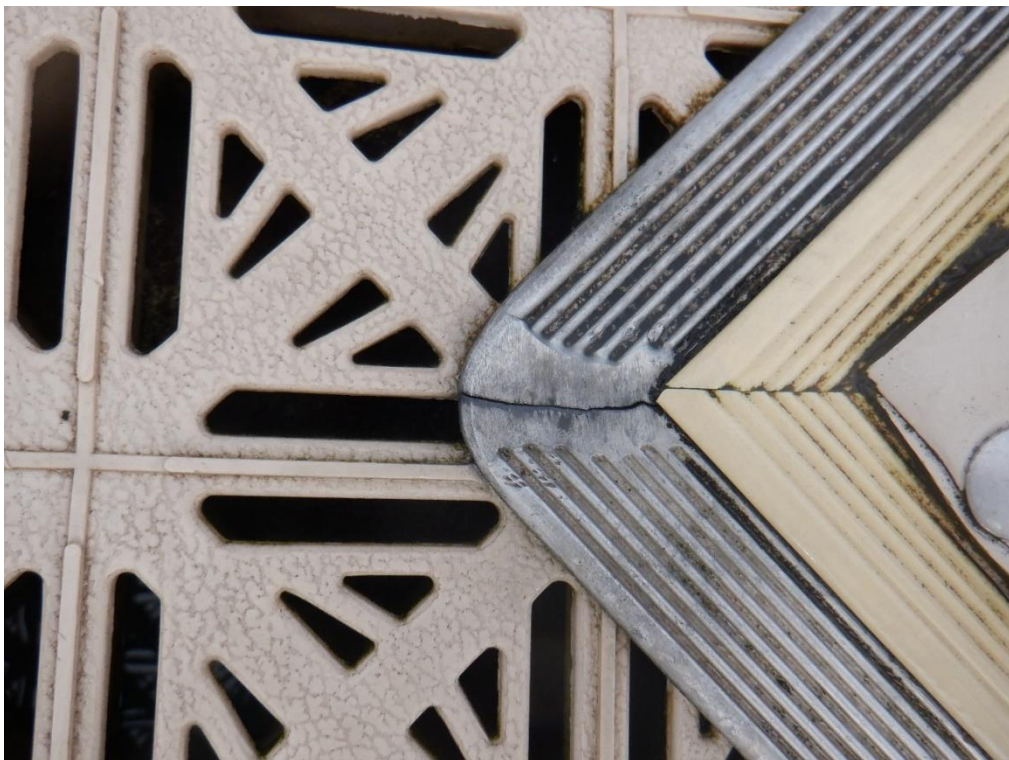
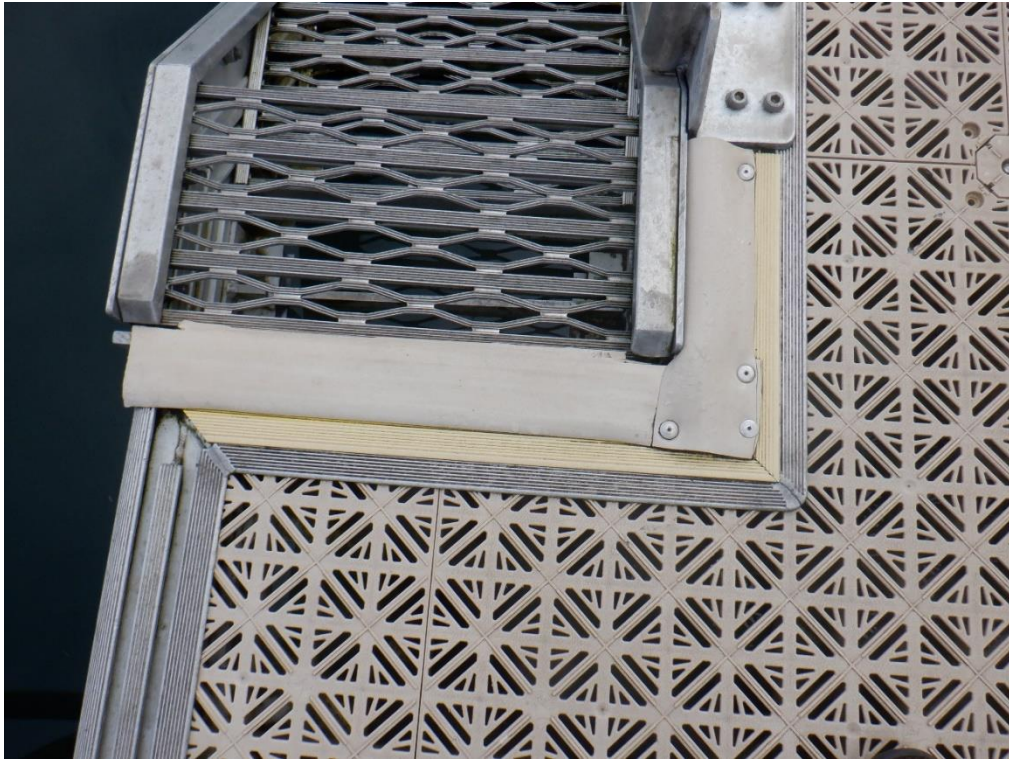
- The pontoon aluminium frame on P22 is showing cracking to the aluminium at both corners of the steps into the water.

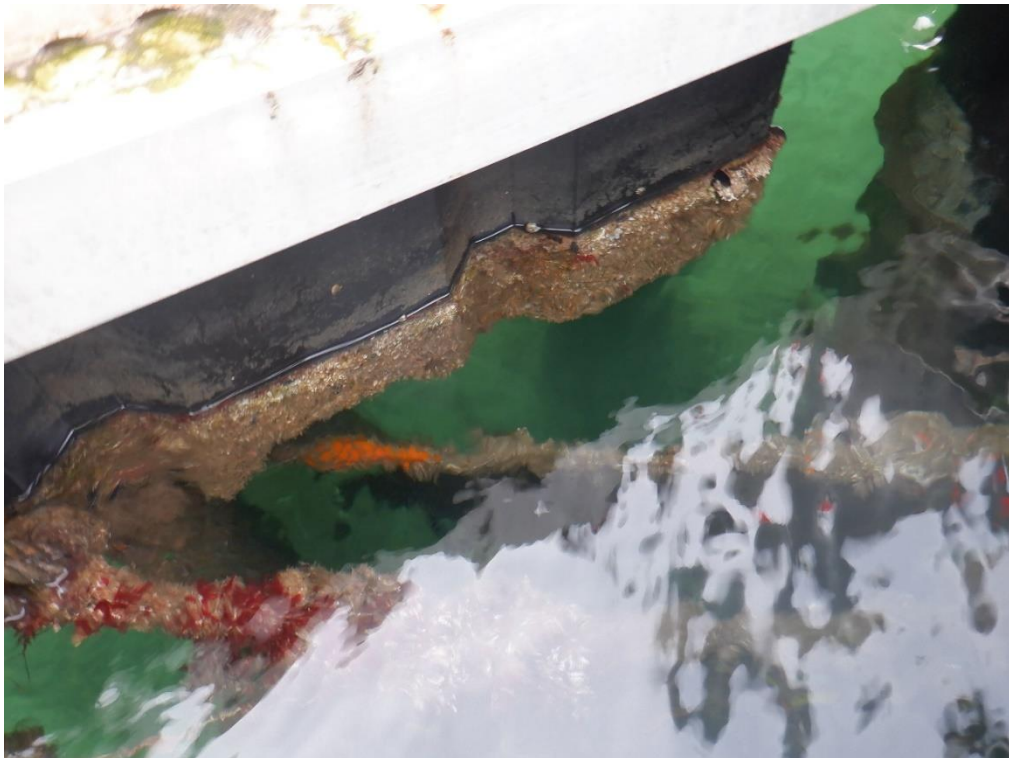
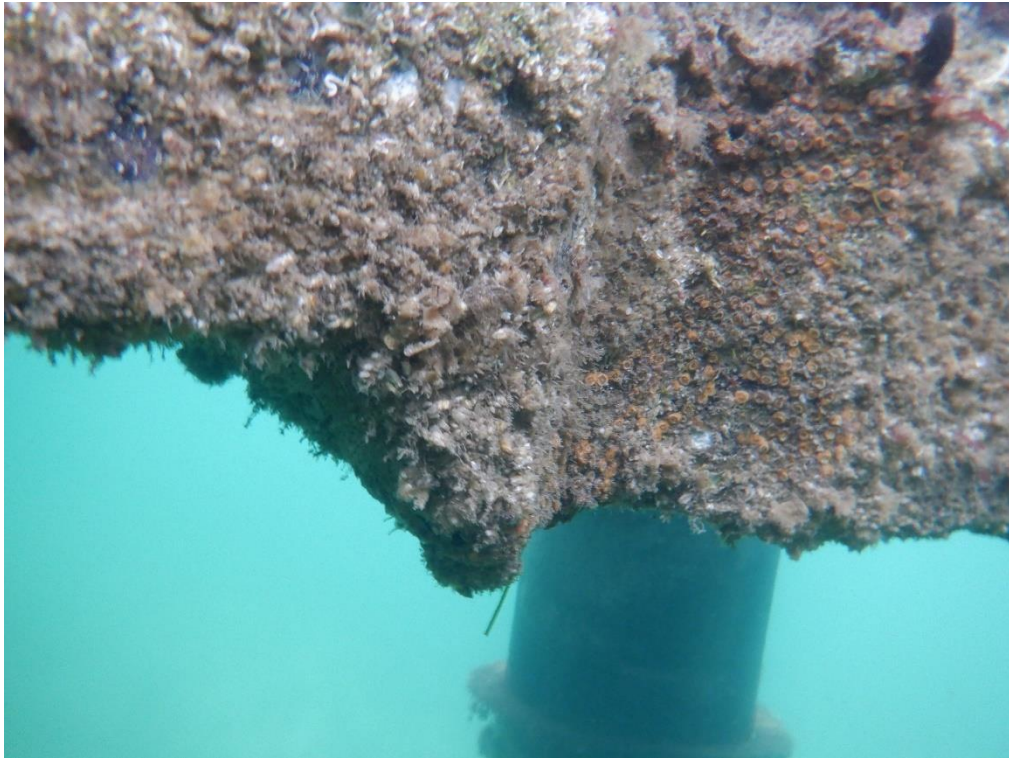
- The pontoon floats are heavily encrusted with marine growth generally.

Both the pontoons and predator exclusion nets under the pontoons are subject to marine growth build up over time. As the amount of marine growth increase, it weighs more and this additional weight causes a dampening of the response of the pontoons to wave action, and hence increases the stresses experienced by the pontoon frames.

Repair and ongoing maintenance at site is important, and this should receive adequate attention. In particular, much of the structure is located in seawater, and this will allow the build up of marine growth on nets and pontoons, adding weight to the supporting structure over. This marine growth should be cleaned off the predator exclusion nets under the pontoons and off the pontoons themselves on a regular basis. Intervals of 6 to 12 months between cleans may be appropriate, and this can be assessed on site.

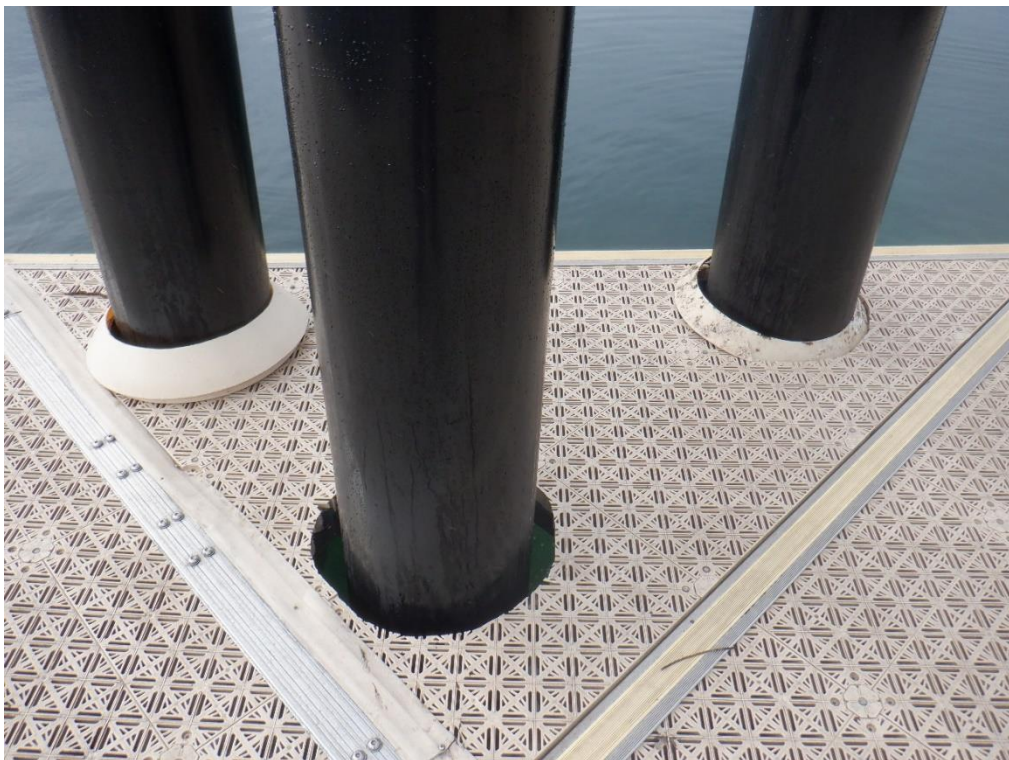
- The three corner piles at the western corner have their collar rings displaced or missing from the pontoons.

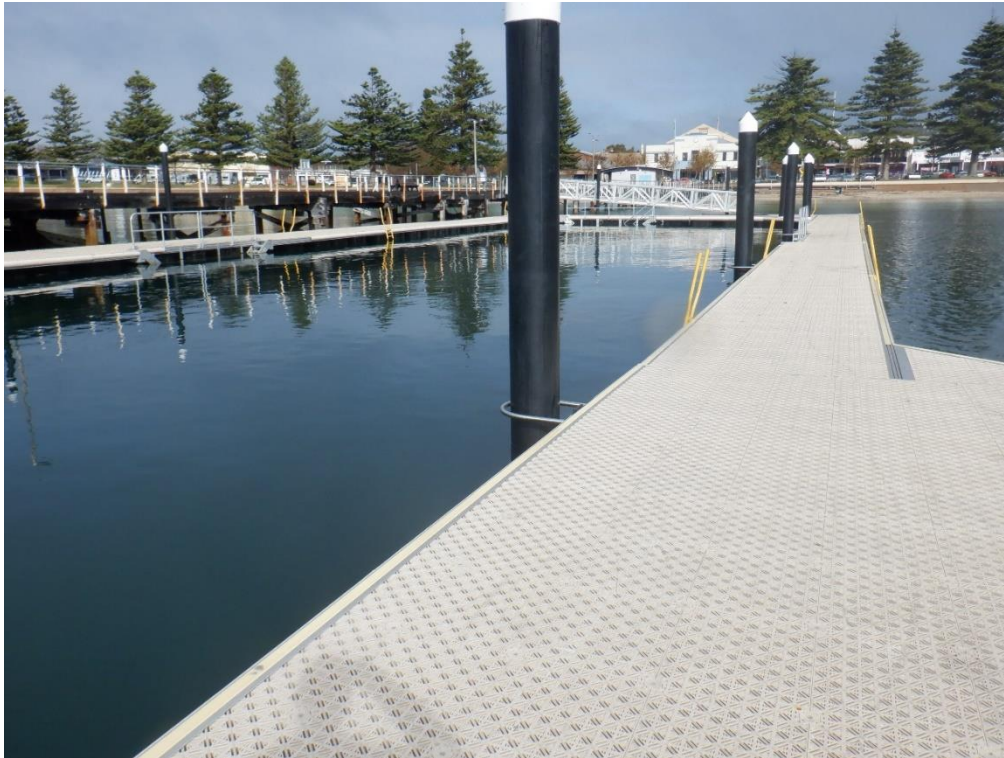
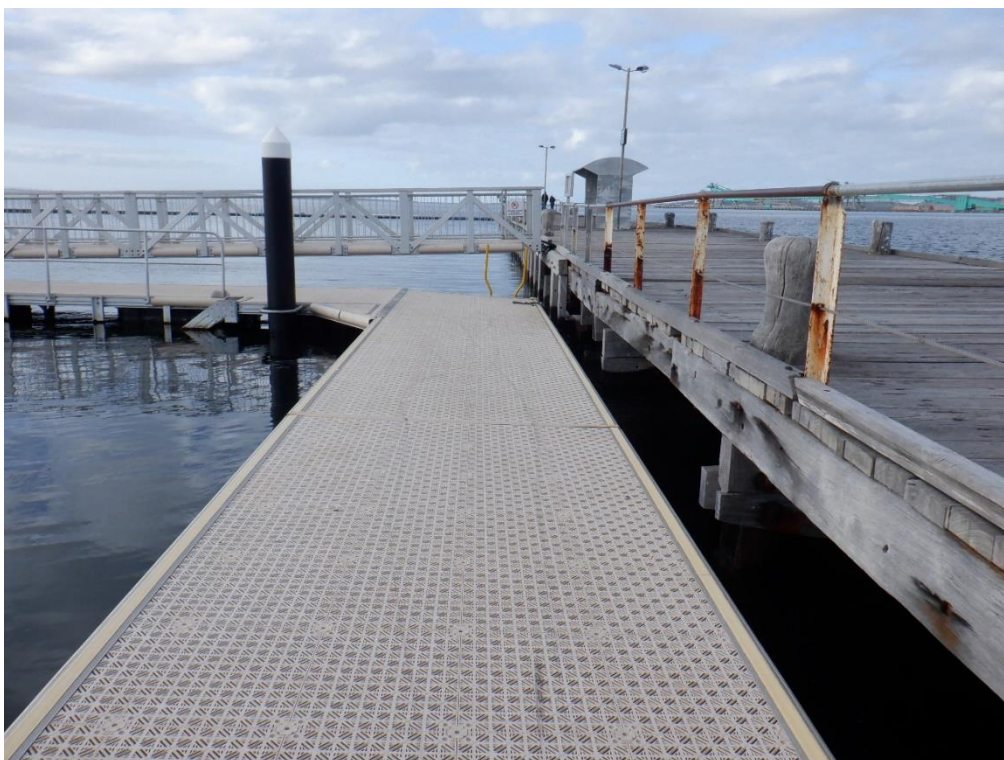
These results show listing of the pontoons, generally sideways, varying from - 3.05° to 2.9°.

The above measurements are in degrees. For the perpendicular to pontoon measurement a positive figure indicates that the pontoon was lower on the inner edge of the swim enclosure than the outer. For the longitudinal measurement a positive figure indicates that the outer seaward end (north eastern or north western end) is lower than the shoreward end of the pontoon.

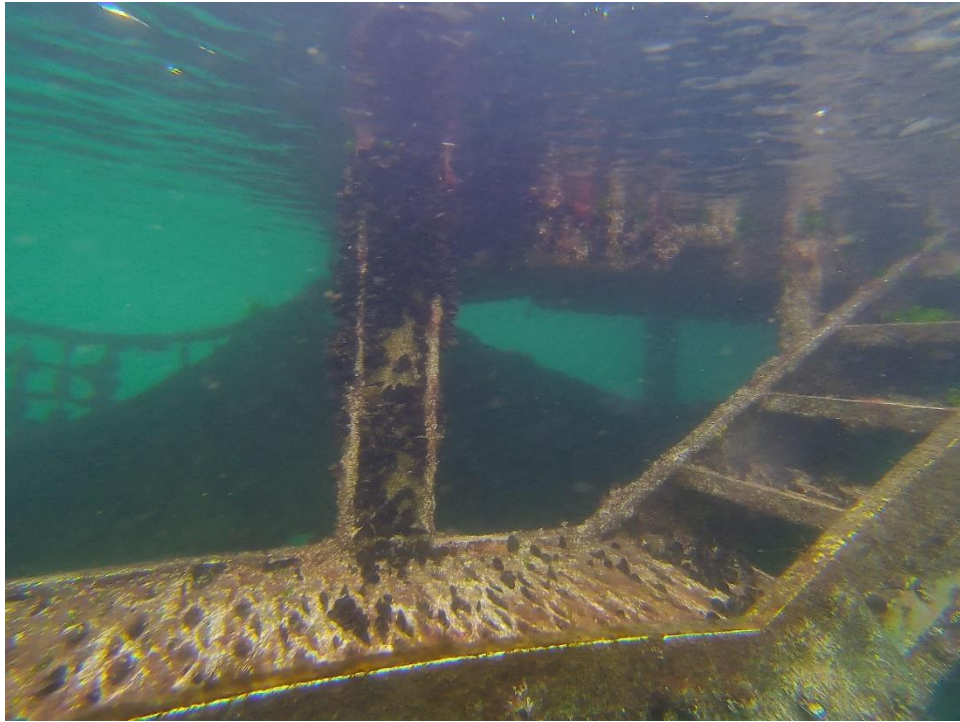
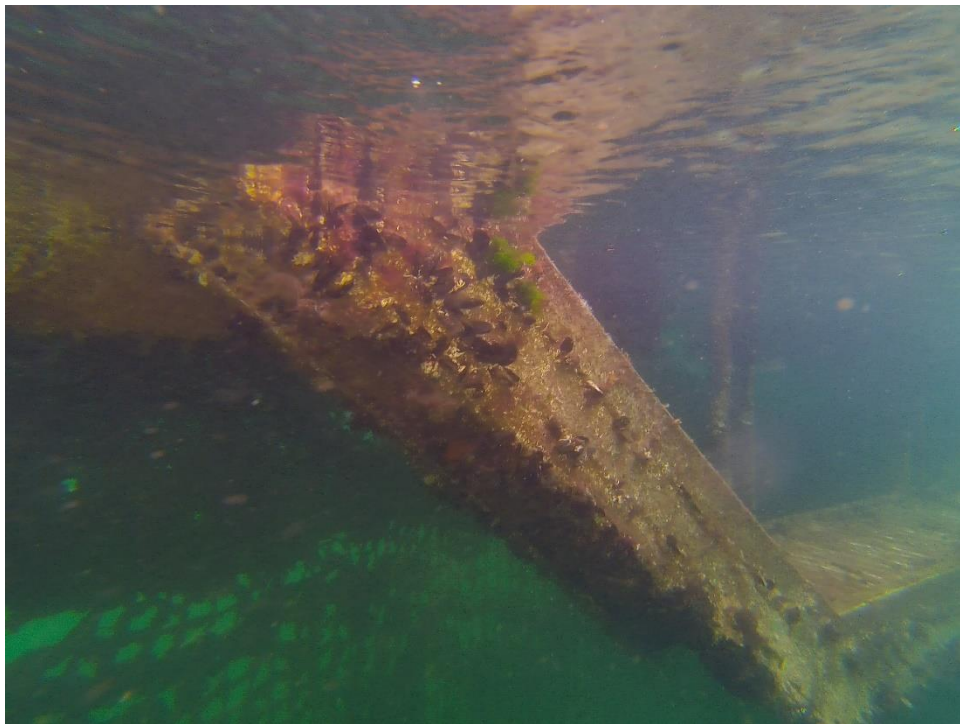
- The steps into the water from the pontoons, on pontoons P4, P8, P13 and P22 are all typically well encrusted with marine growth.

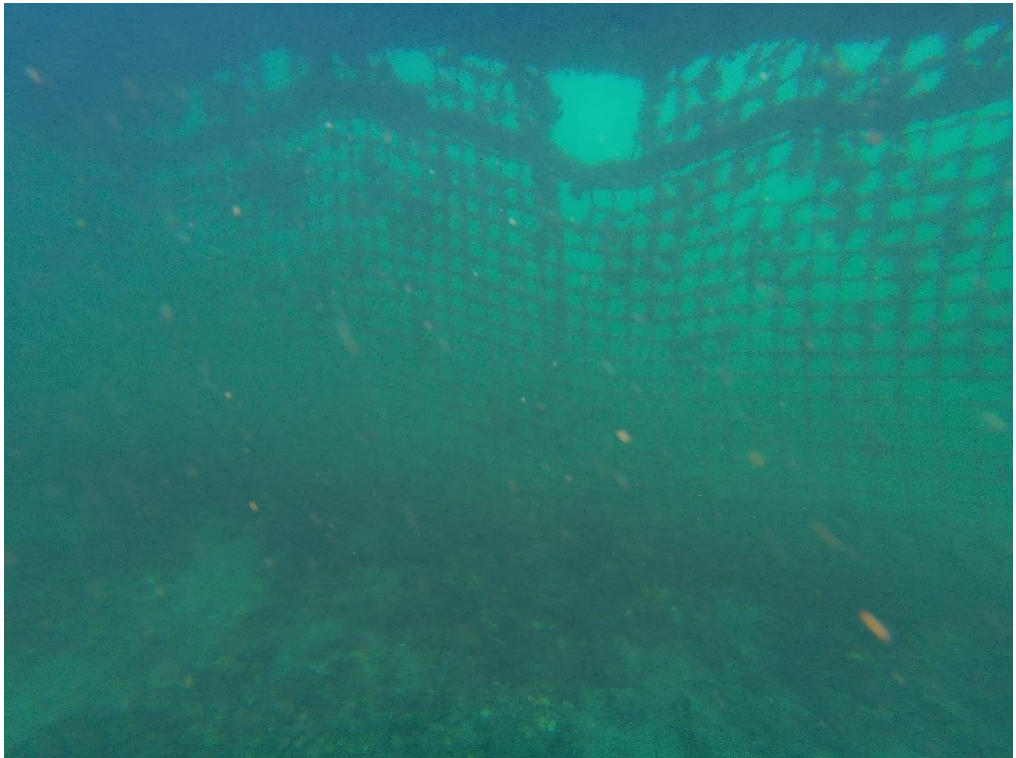
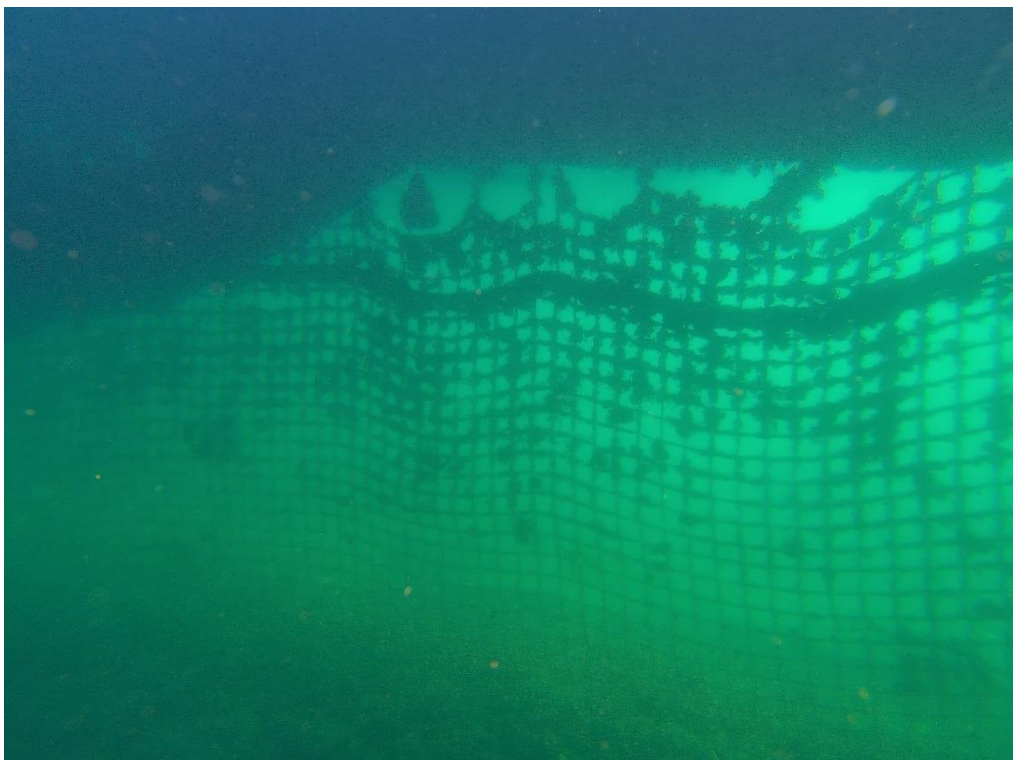
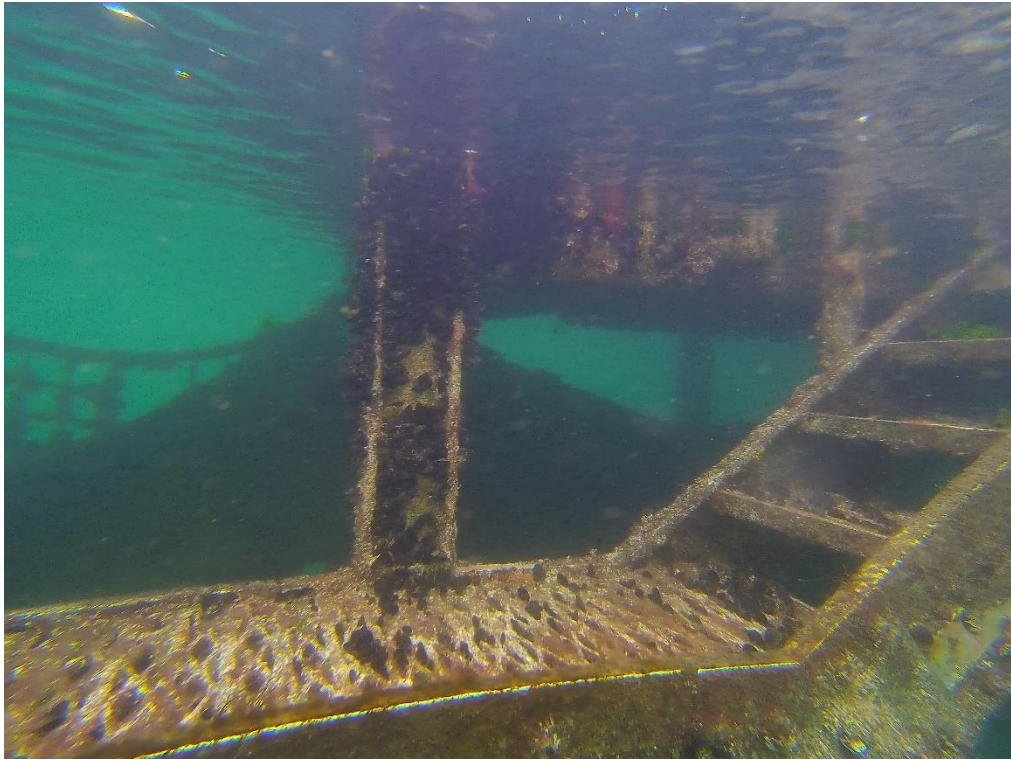
- There were some large gaps over the nets, under the pontoons. However, it is not known how ineffective these gaps would make the nets.

- Replace the existing predator exclusion nets under the pontoons with new.
- It is recommended that two sets of nets be made, and one set placed in storage. Hence, when cleaning or repair of the nets is required the nets can be swapped out and cleaned off site.

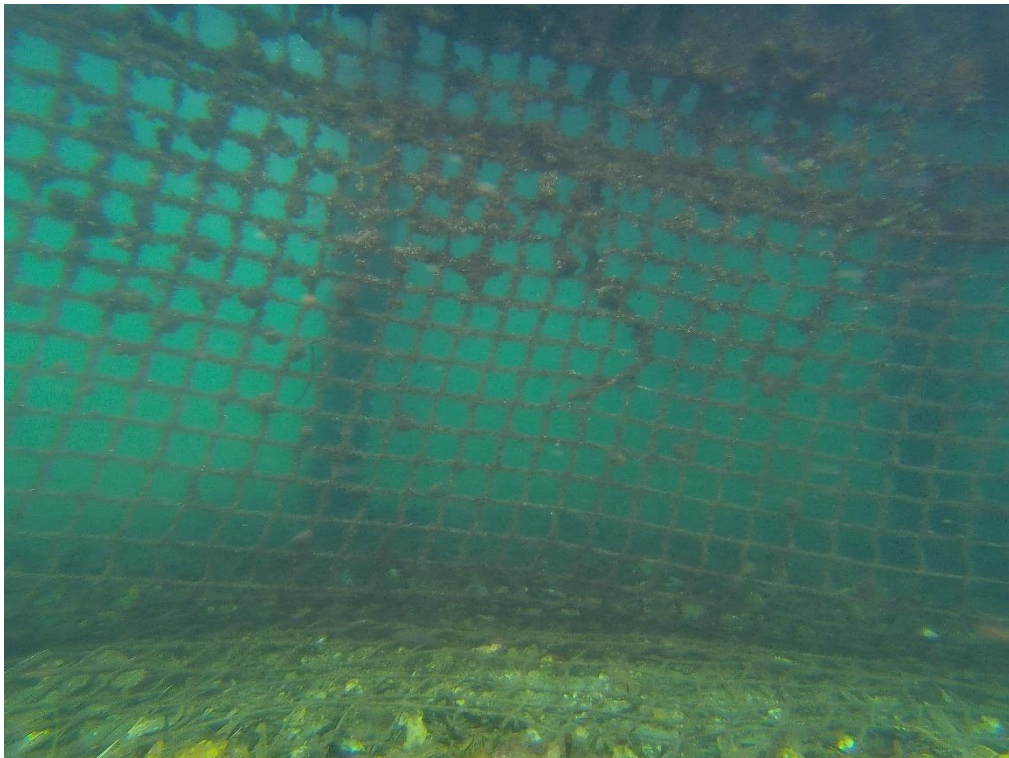
- The bottom of the nets lay on the seabed.

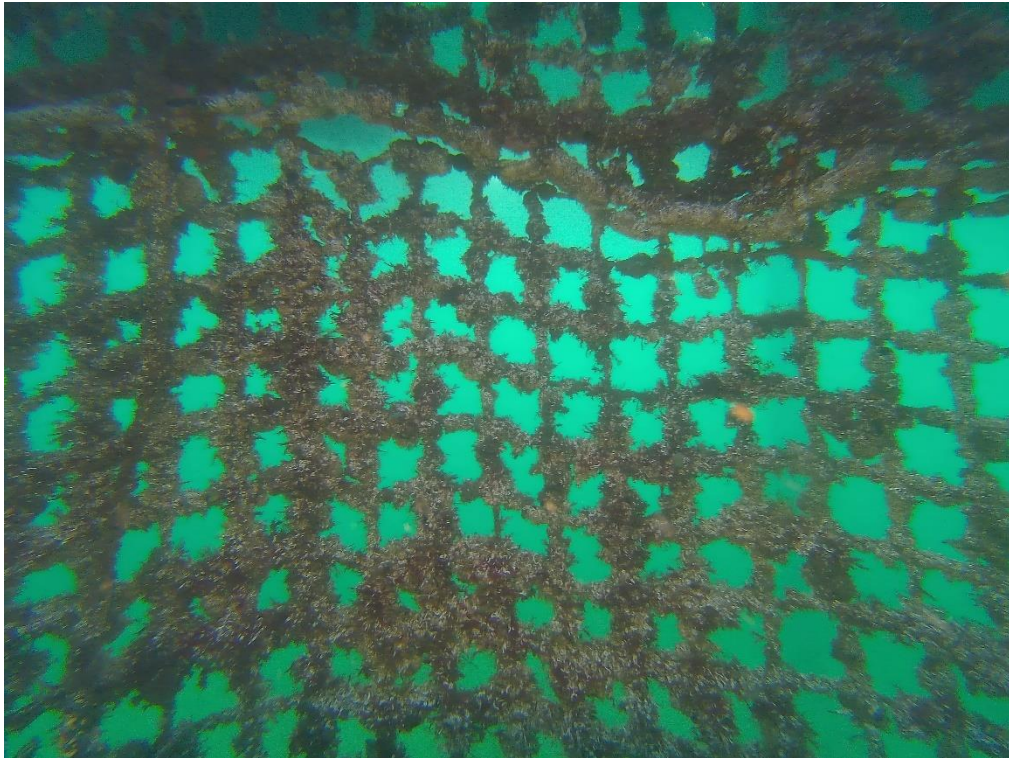
- There was substantial marine growth on the nets (even though they were cleaned September 2021).
