12. COUNCIL REPORTS FOR DECISION**12.1. PORT LINCOLN TOWN JETTY SWIMMING ENCLOSURE**

REPORT INFORMATION	
Report Title	Port Lincoln Town Jetty Swimming Enclosure
Records Reference	9.24.1.2 REP23117
Organisational Unit	Environment & Infrastructure
Responsible Officer	Project Manager - Master Plan Projects - Kathleen Brannigan
Report Attachment/s	Yes Attachment 8 I223976 Assessment Report on Town Jetty Swimming Enclosure (June 2022) I231611 Peer Review of Assessment Report on Town Jetty Swimming Enclosure (July 2023)
REPORT PURPOSE	
The purpose of this report is to provide Council with a report about the current swimming enclosure pontoon structure at the Port Lincoln Town Jetty and recommend next steps.	
REPORT DECISION MAKING CONSIDERATIONS	
Council Role	Owner / Custodian - Manage community assets including buildings, facilities, public space, reserves on behalf of current and future generations
Strategic Alignment	SDP GOAL: Goal 5: Community Assets and Placemaking SDP ACTION: Not Applicable

Project No.: 22206
June 2022

PEER REVIEW OF SWIM ENCLOSURE FAILURE REPORT

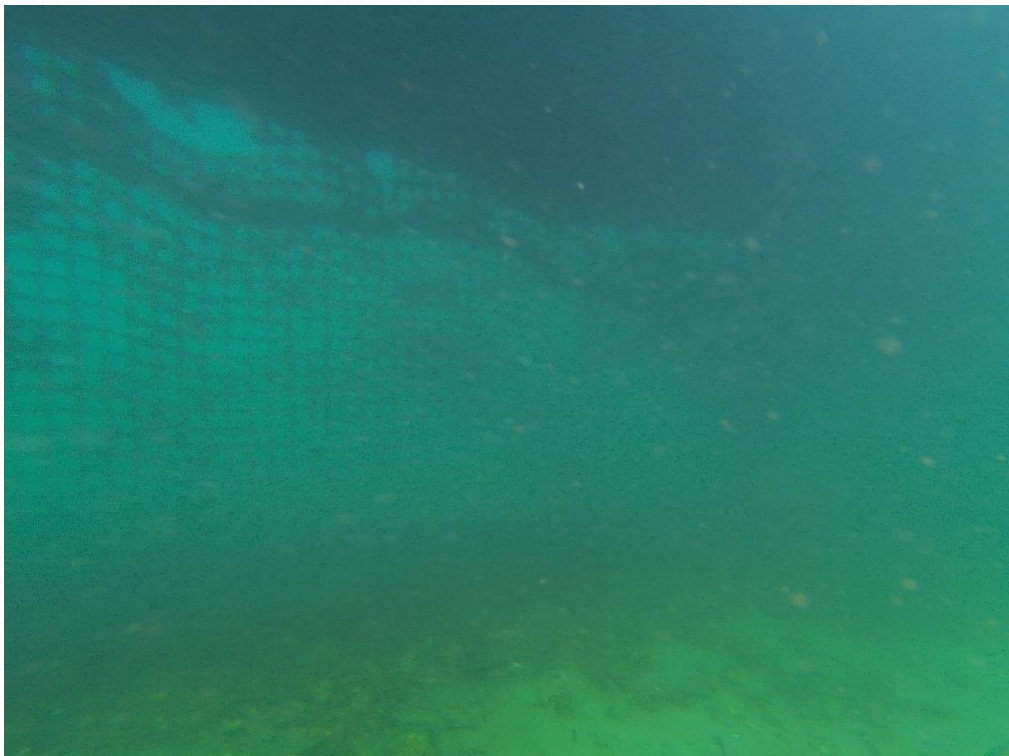
- The condition of the nets was reported by Southern Ocean Drive and Marine as poor.

The predator exclusion nets hung under the pontoons are in poor condition.

- Replace the existing predator exclusion nets under the pontoons with new.
- It is recommended that two sets of nets be made, and one set placed in storage. Hence, when cleaning or repair of the nets is required the nets can be swapped out and cleaned off site.

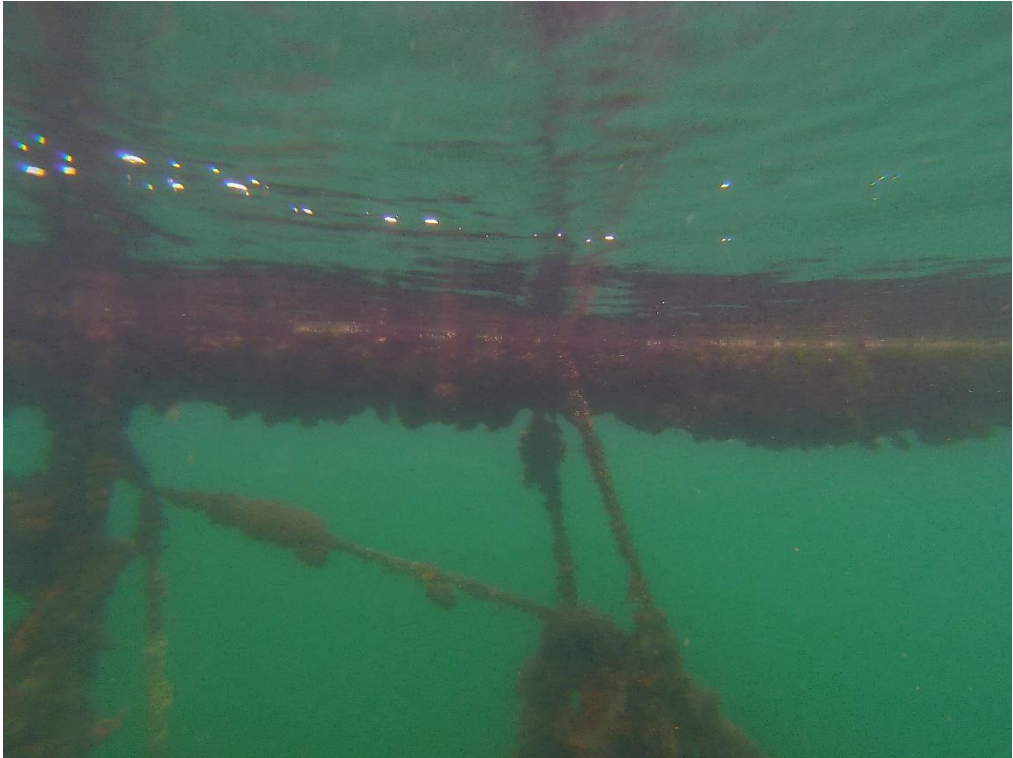
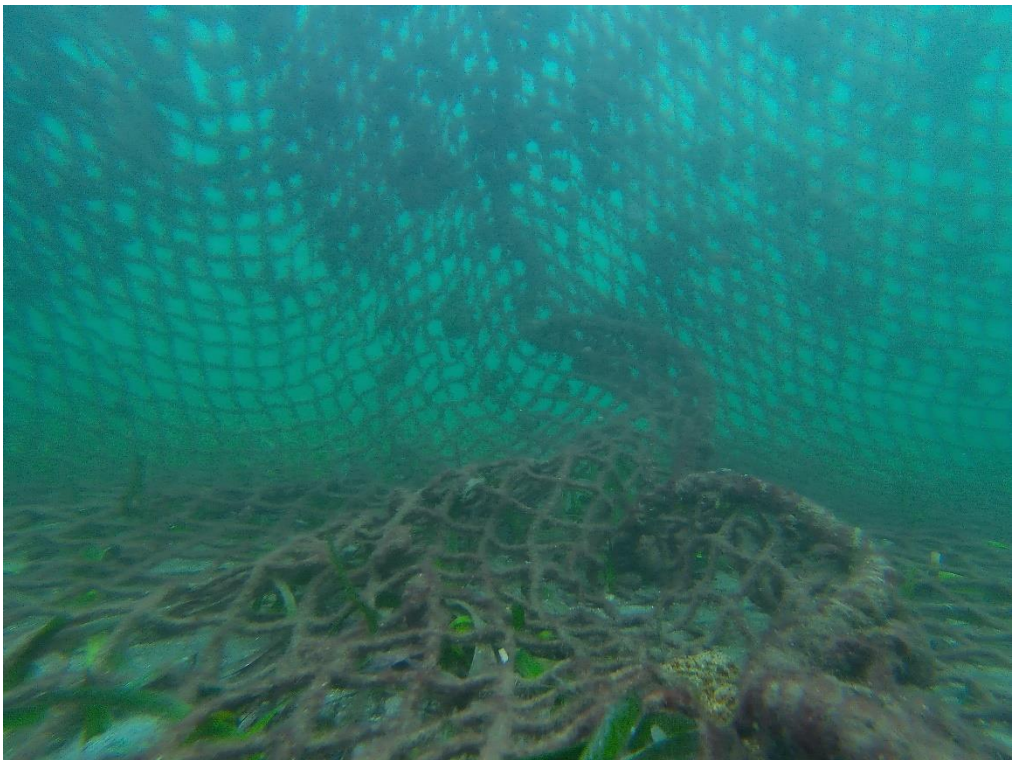
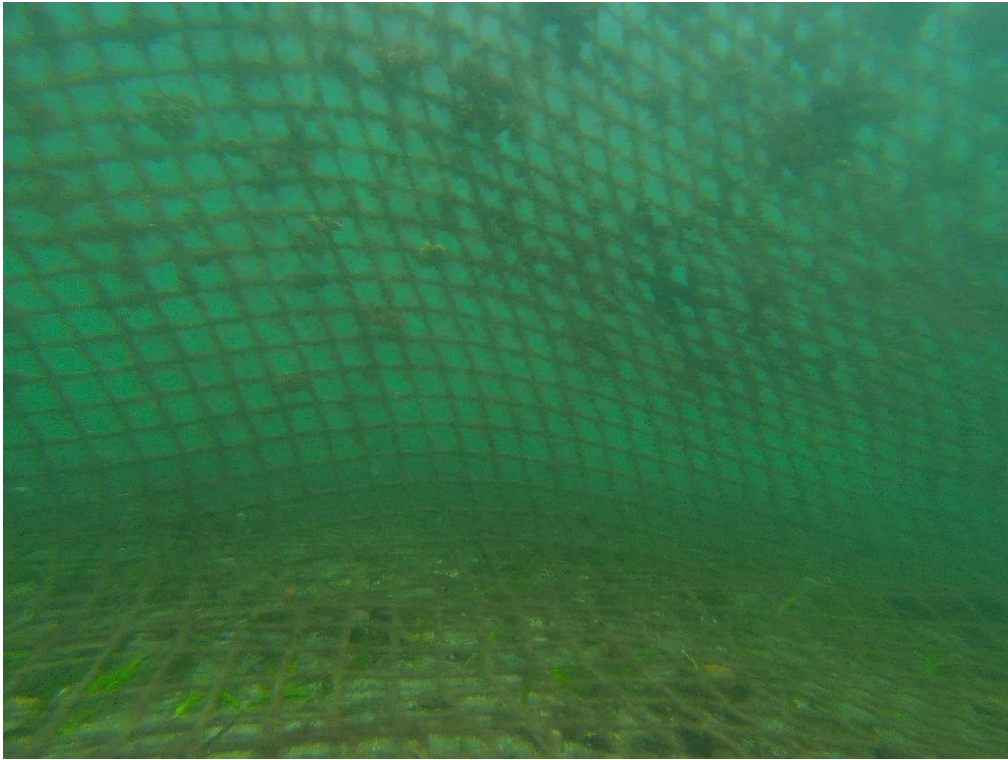
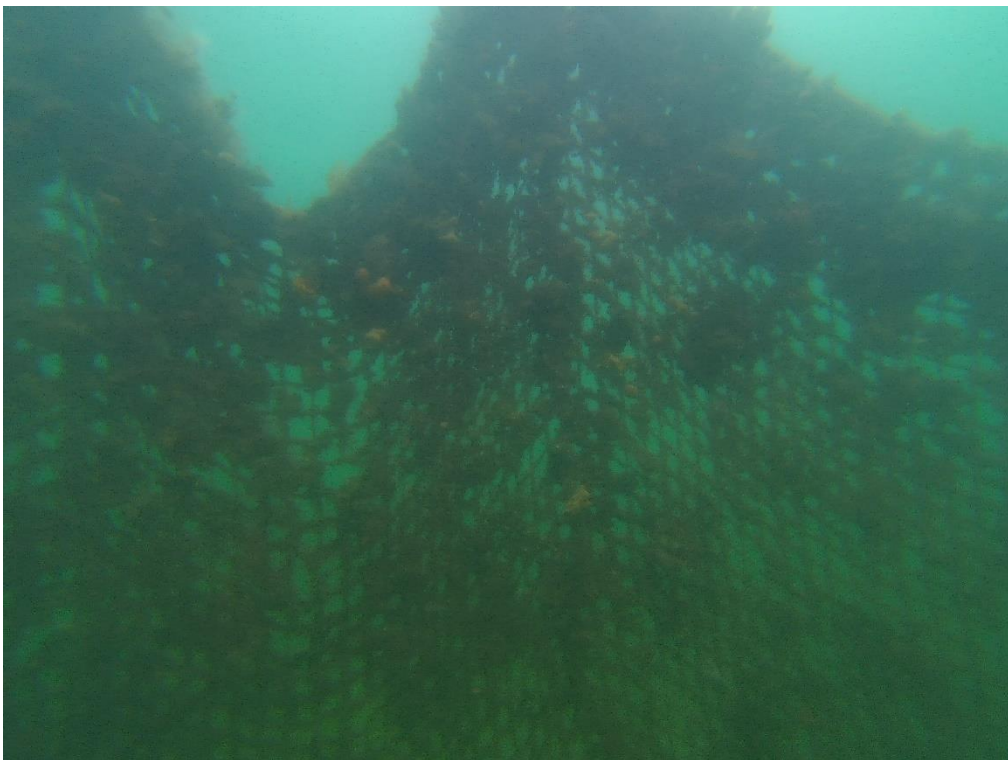
The predator nets under do not generally extend to the HDPE pipes at the surface, but extend down to the seabed. They are heavily encrusted with marine growth, and reportedly have never been cleaned. The nets appear to be the same 50mm square 4m fibre netting used under the pontoons.

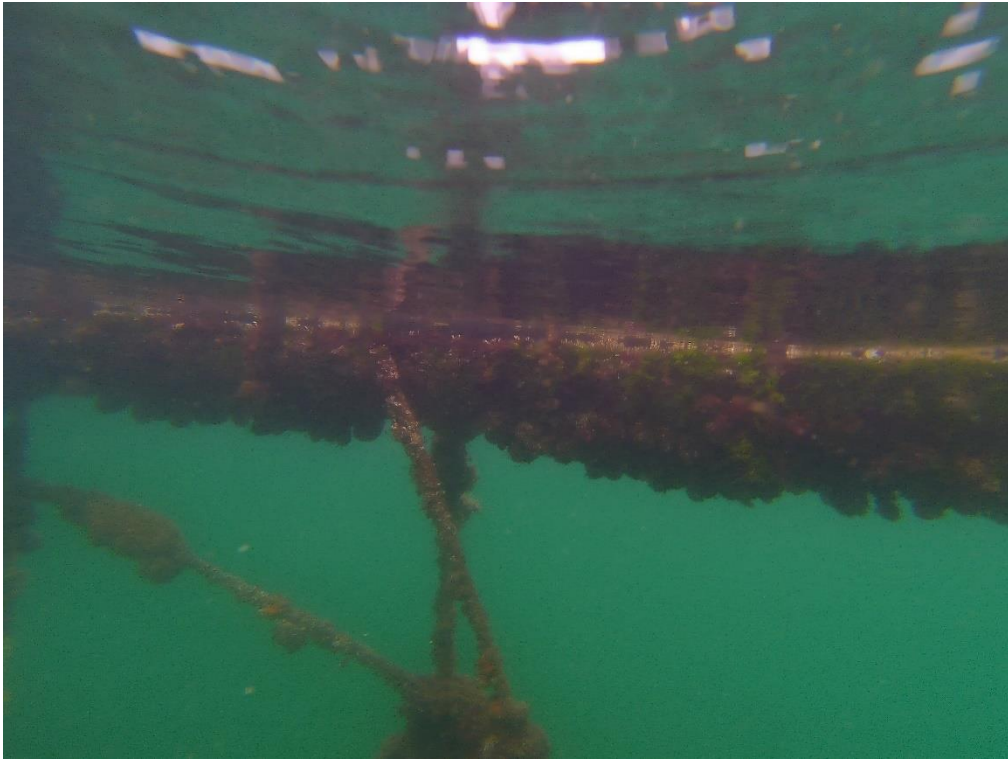
The HDPE pipes appear to be in good condition, but are heavily encrusted with marine growth.

- It is not recommended that the wave attenuator be relocated.
- No work is recommended for the wave attenuator.

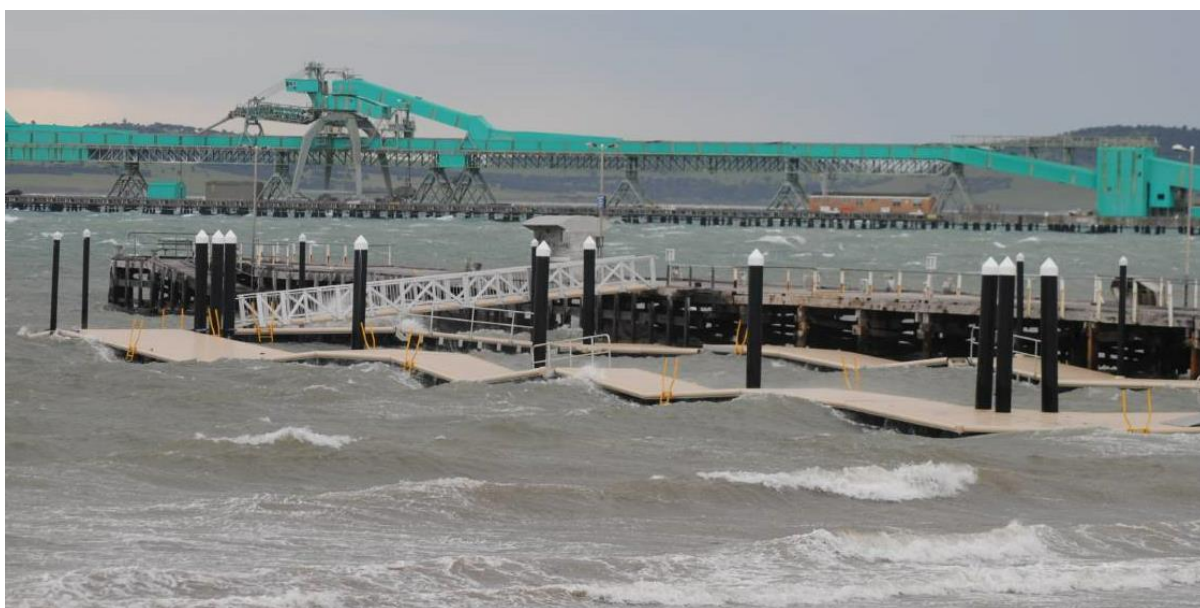
Imagery of the swim enclosure found on the internet suggests a 0.5-0.6m wave is likely to have occurred. An example is shown below however the date the image was taken cannot be confirmed.

Figure 1: Image obtained from internet search showing an estimated 0.5-0.6m wave event at the swim enclosure.

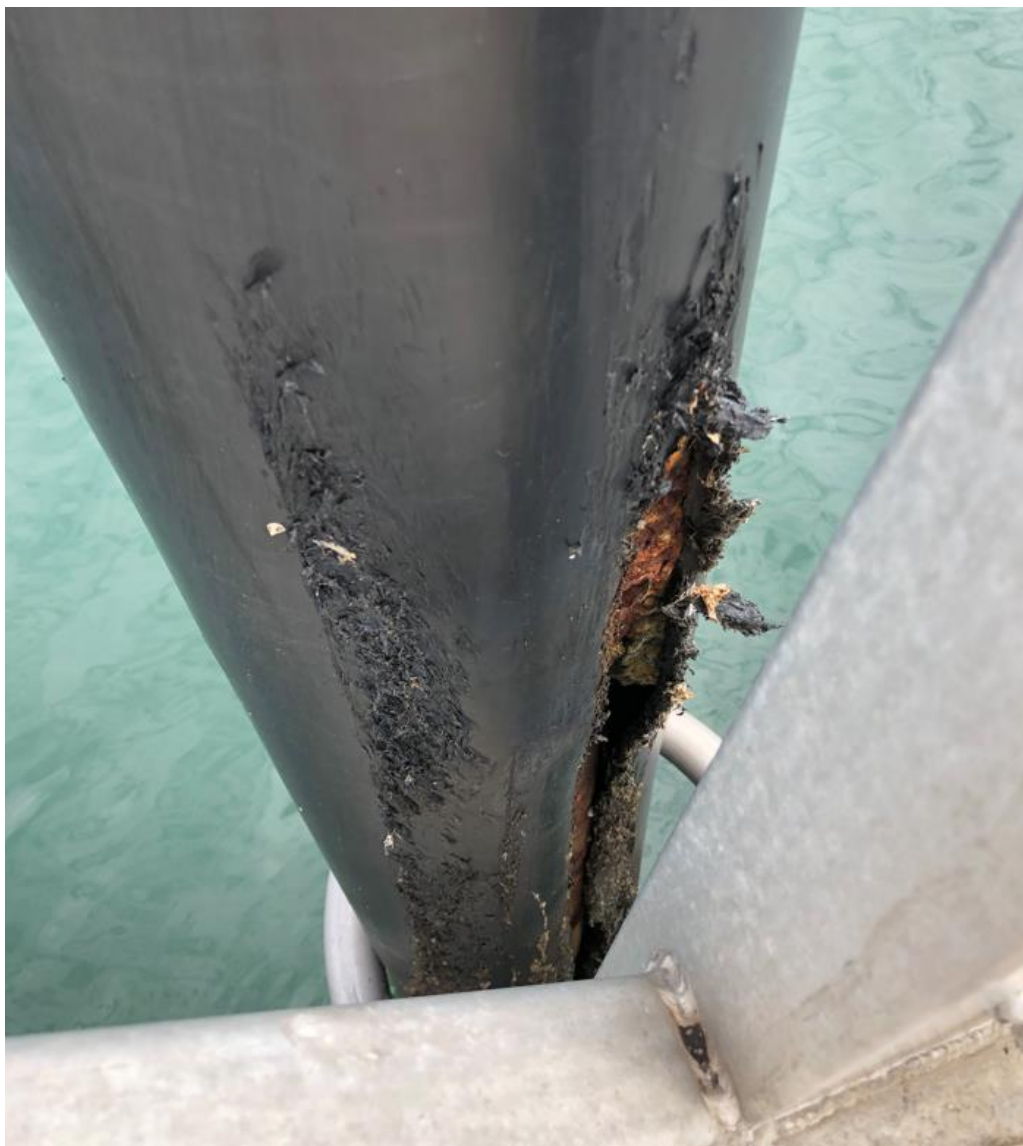
During the site attendance on 13 September 2022 it was noted that a larger opening had formed in the HDPE sleeve to the pile located to the south of the lower end of the southern gangway, at pontoon P10. The opening appeared to have been formed due to contact with a gangway framing element. The HDPE sleeve is no longer effective and requires replacement.

Figure 2: Photograph taken on 13 September 2022 showing the penetration of the HDPE sleeve to the pile at pontoon unit P10.

- Tonkin considers recommendations in this section appropriate and further that the pile inside the damaged HDPE sleeve should be inspected to determine extent of corrosion and replaced if required.

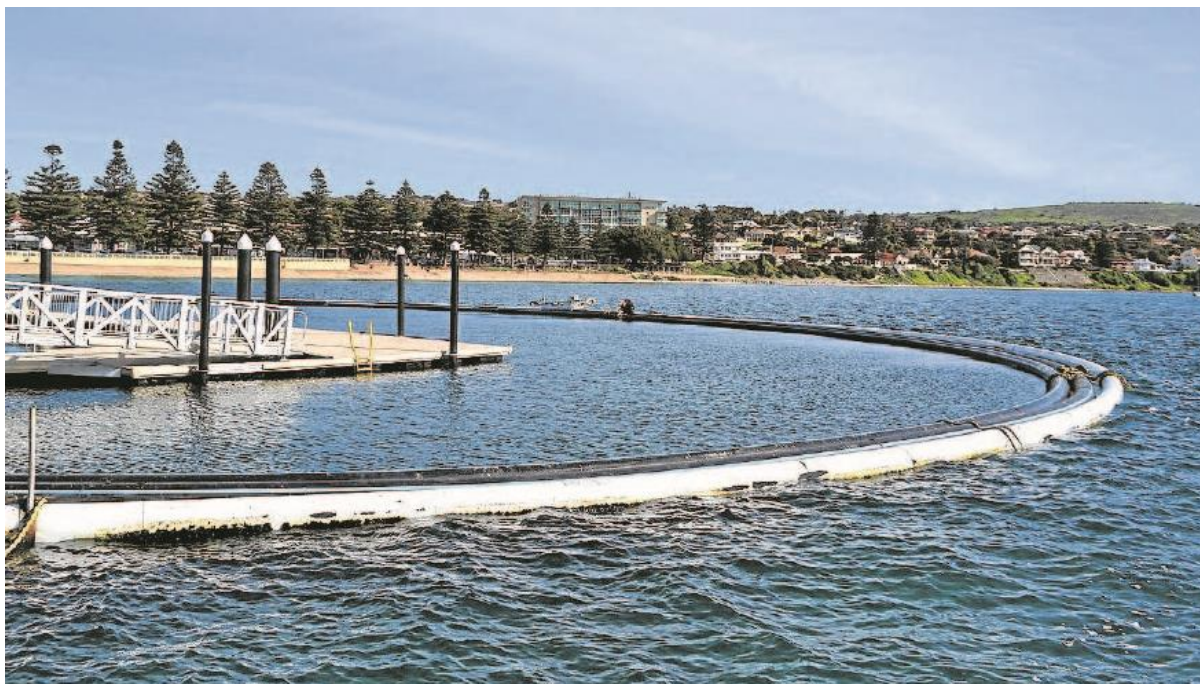
Figure 3: Attenuation of small waves by the floating tubes.

Wave attenuation of larger waves requires larger structures that disturb a larger depth of the water to prevent the wave passing.
