12. COUNCIL REPORTS FOR DECISION**12.1. PORT LINCOLN TOWN JETTY SWIMMING ENCLOSURE**

REPORT INFORMATION	
Report Title	Port Lincoln Town Jetty Swimming Enclosure
Records Reference	9.24.1.2 REP23117
Organisational Unit	Environment & Infrastructure
Responsible Officer	Project Manager - Master Plan Projects - Kathleen Brannigan
Report Attachment/s	Yes Attachment 8 I223976 Assessment Report on Town Jetty Swimming Enclosure (June 2022) I231611 Peer Review of Assessment Report on Town Jetty Swimming Enclosure (July 2023)
REPORT PURPOSE	
The purpose of this report is to provide Council with a report about the current swimming enclosure pontoon structure at the Port Lincoln Town Jetty and recommend next steps.	
REPORT DECISION MAKING CONSIDERATIONS	
Council Role	Owner / Custodian - Manage community assets including buildings, facilities, public space, reserves on behalf of current and future generations
Strategic Alignment	SDP GOAL: Goal 5: Community Assets and Placemaking SDP ACTION: Not Applicable

Project No.: 22206
June 2022

PEER REVIEW OF SWIM ENCLOSURE FAILURE REPORT

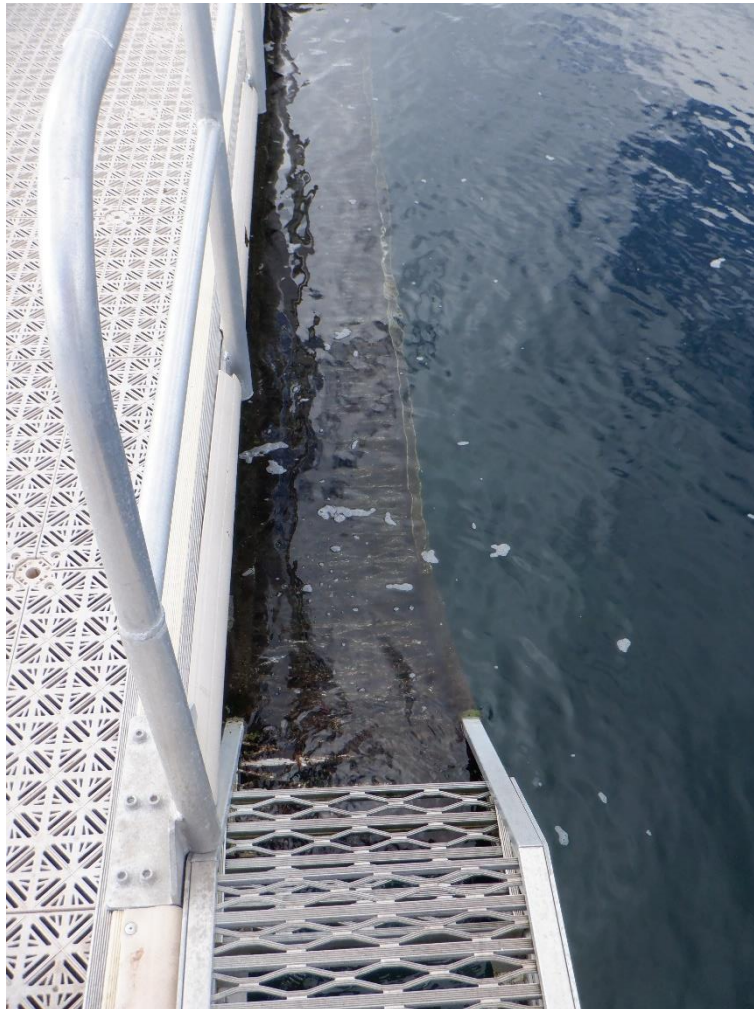
Four of the pontoons (one on each edge of the enclosure) have steps with platforms leading into the water. These are pontoons P4, P8, P13 and P22. The original details of these step platforms are shown on drawing 4515AC-SP9.

It is reported that a local fabricator has retrofitted heavy channels to these steps to reduce flex in this structure. This was reportedly arranged by Council.

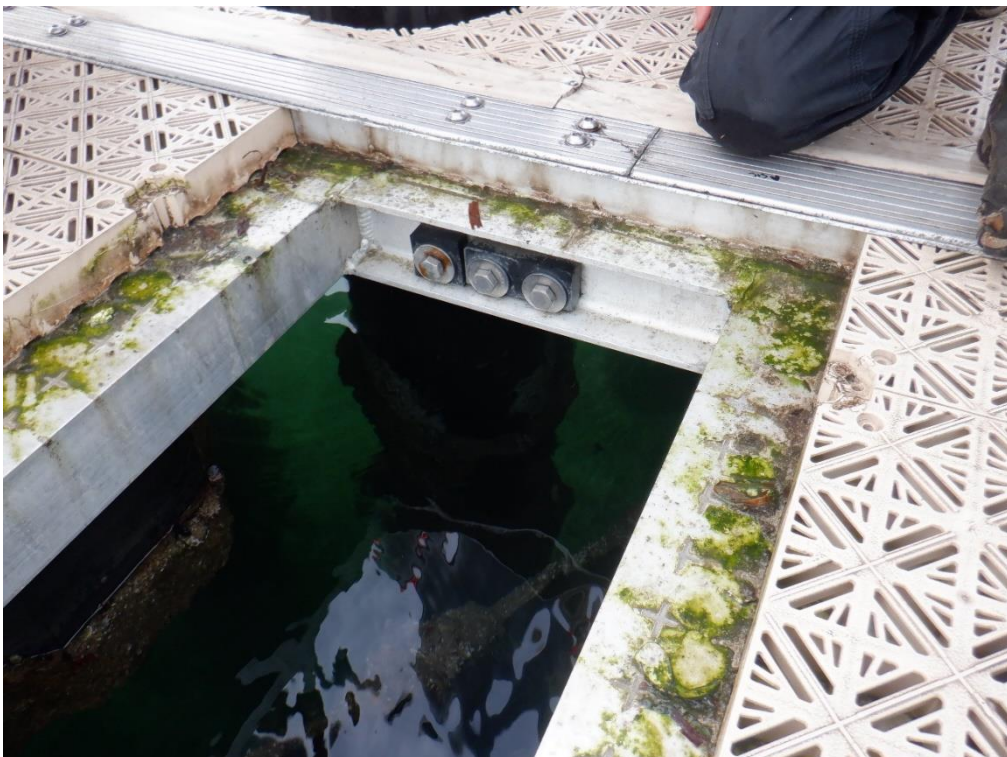
The pontoons are joined together with “Flexi Joins”, which are described on Seaslip drawing 4515AC-P9. These incorporate three 25mm blocks of rubber (one inside the end channel of each pontoon and one between the pontoons) which are bolted through with stainless steel bolts.

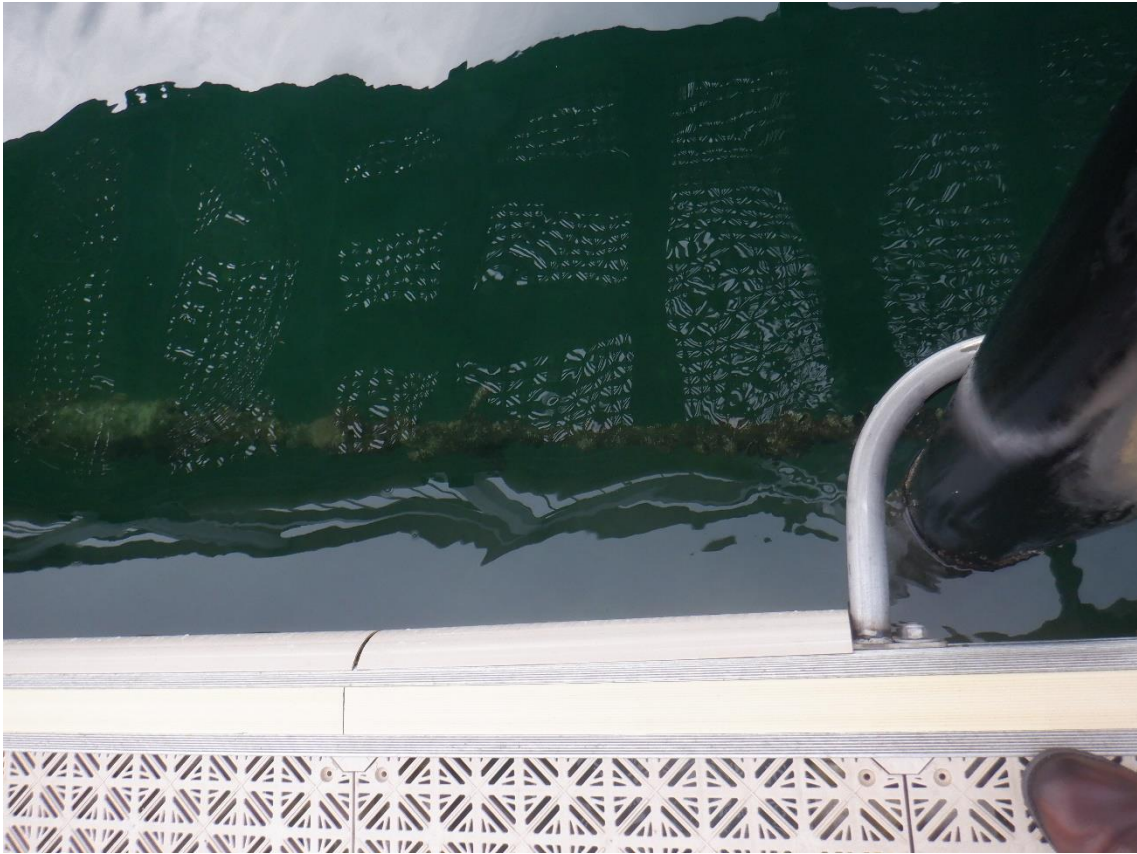
Mooring ropes from the pontoons, running as spring lines to the seabed were also noted at:

These mooring lines are not in the Seaslip documentation, and no details of them are known, including:

- why they were installed,
- who they were installed by,
- what they are anchored to at the seabed, and
- the type of rope, and how fixed.

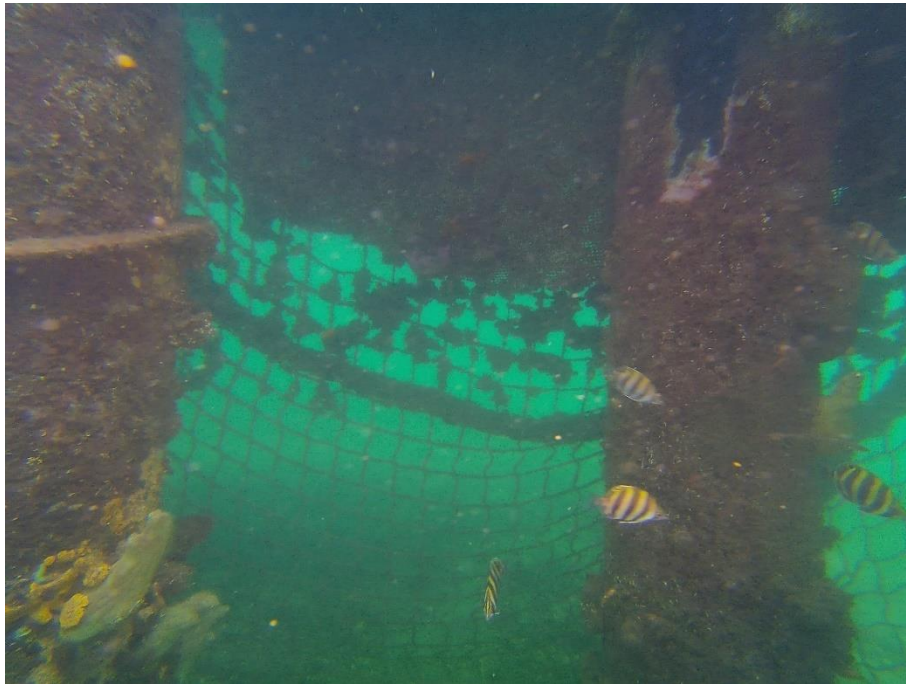
- The condition of the nets was reported by Southern Ocean Drive and Marine as poor.

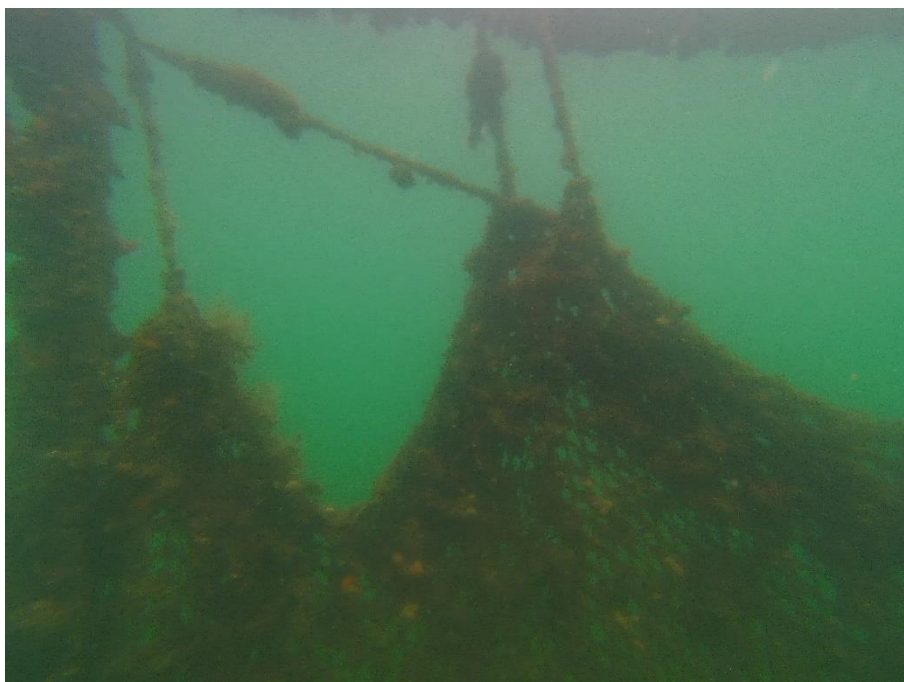
The predator nets under do not generally extend to the HDPE pipes at the surface, but extend down to the seabed. They are heavily encrusted with marine growth, and reportedly have never been cleaned. The nets appear to be the same 50mm square 4m fibre netting used under the pontoons.

The HDPE pipes appear to be in good condition, but are heavily encrusted with marine growth.

- It is not recommended that the wave attenuator be relocated.
- No work is recommended for the wave attenuator.

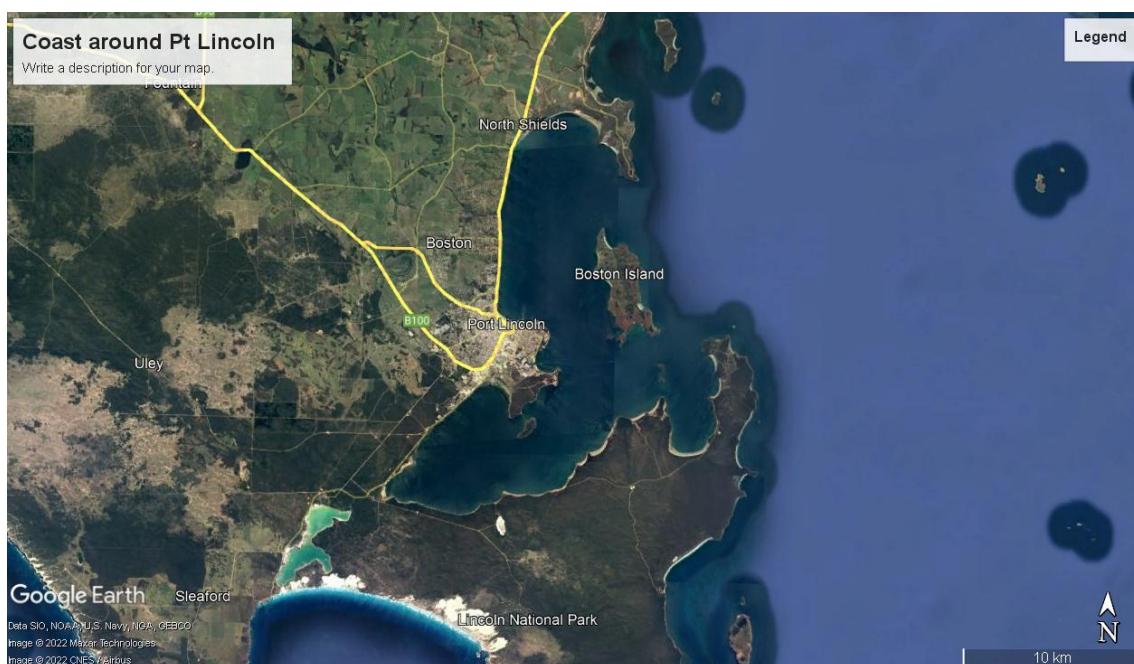
The site is quite protected from by long period ocean swells, as these generally approach from the west or south west. The site is inside Boston Bay, in the lee of Boston Island.

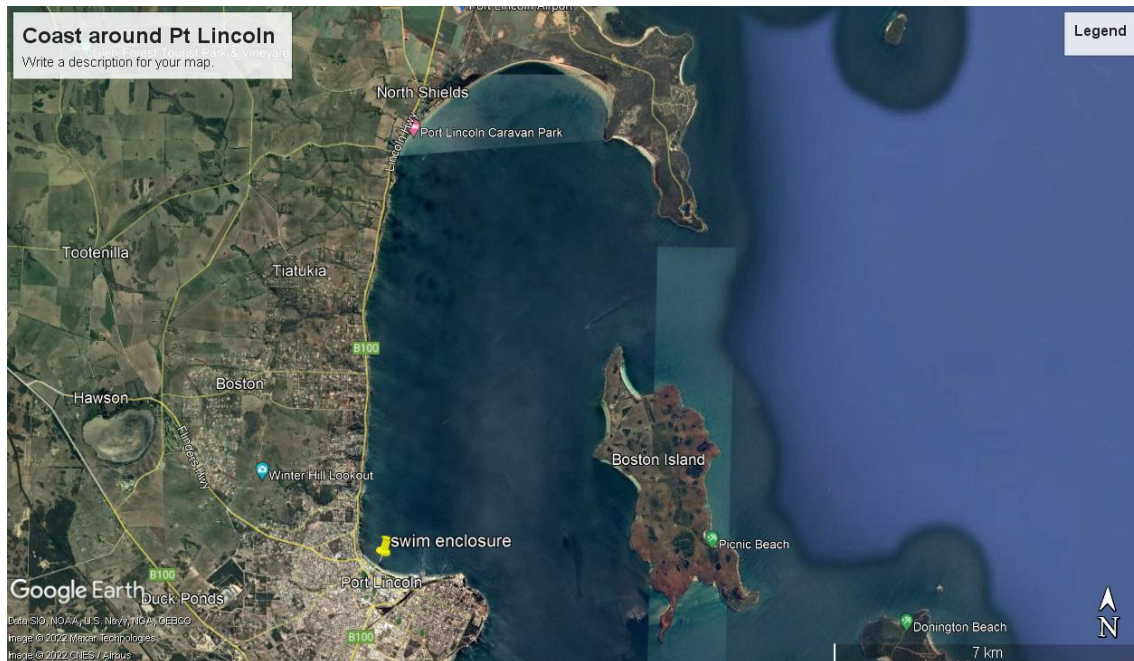
The fetch for this wave generation is limited to the north by Point Boston (11.5km) and Boston Island to the east (6km).
